Summary of FracView* Image Natural Fracture Interpretation for Well Completions – Boggess-3H, 5H, 9H and 13H - Prepared for Northeast Natural Energy

By Dr. Bingjian Li
Advisor – Borehole Image Data Applications
Blackriver Geoscience LLC

Date: July-16th, 2019

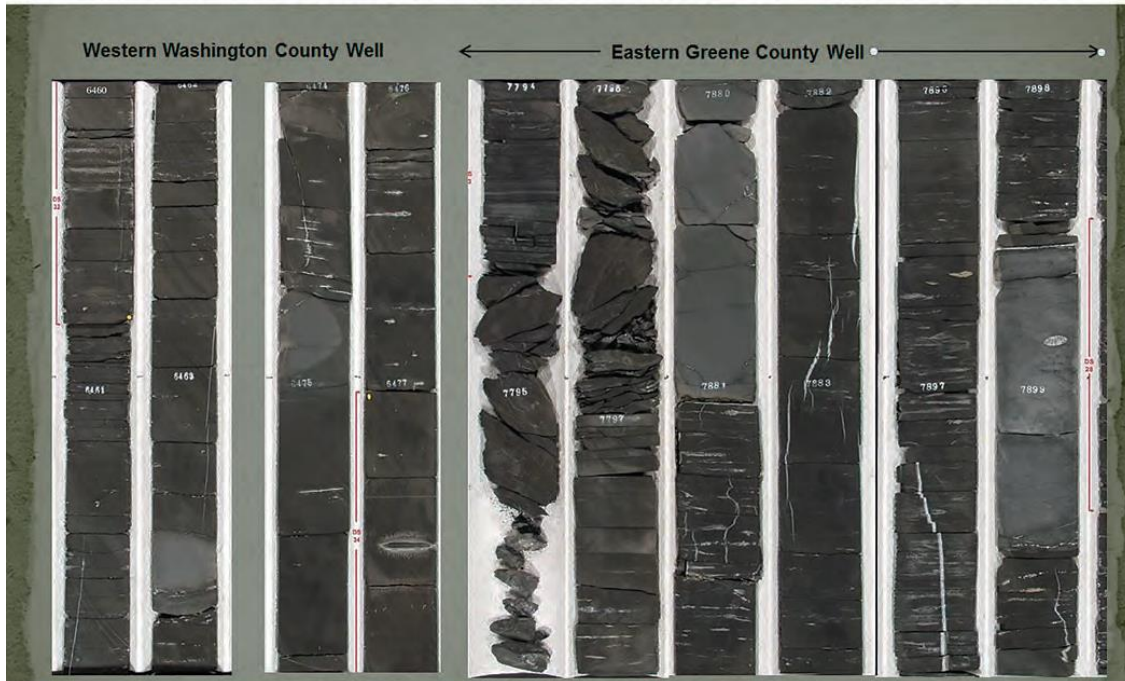
SW PA Core Studies – Natural Fractures Increase to East

The number and width of vertical calcite filled fractures increases significantly from the Western Washington County cores the eastern Greene County cores.

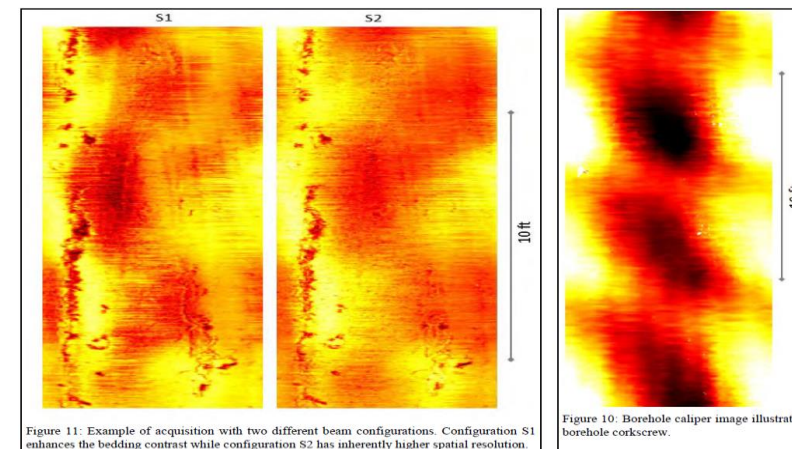
Rock Texture (Bogges-3H)

Figure 10: Borehole caliper image illustrating borehole corkscrew.

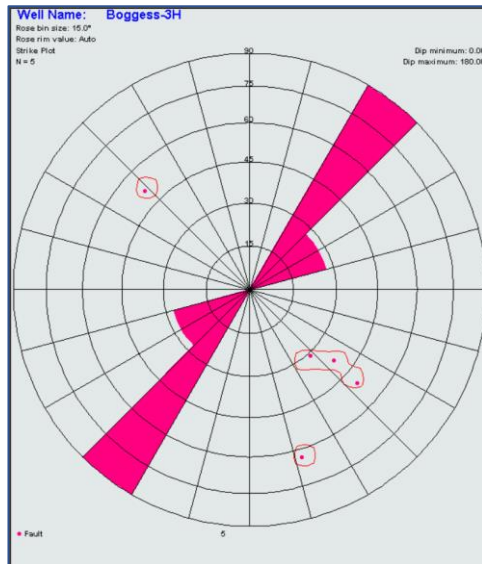
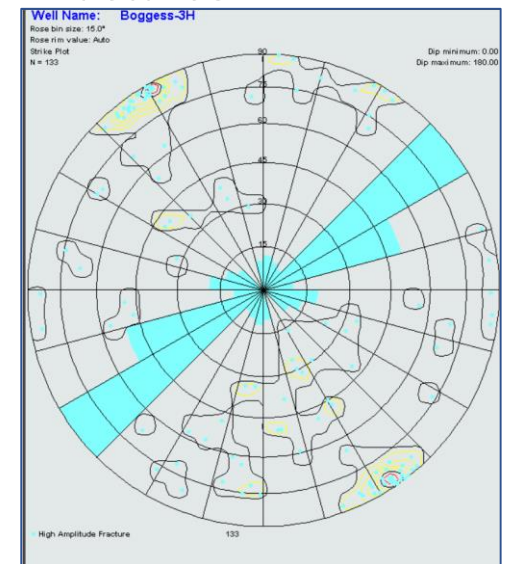
Rose diagram (strike plot) summary for each fracture type – Boggess-3H

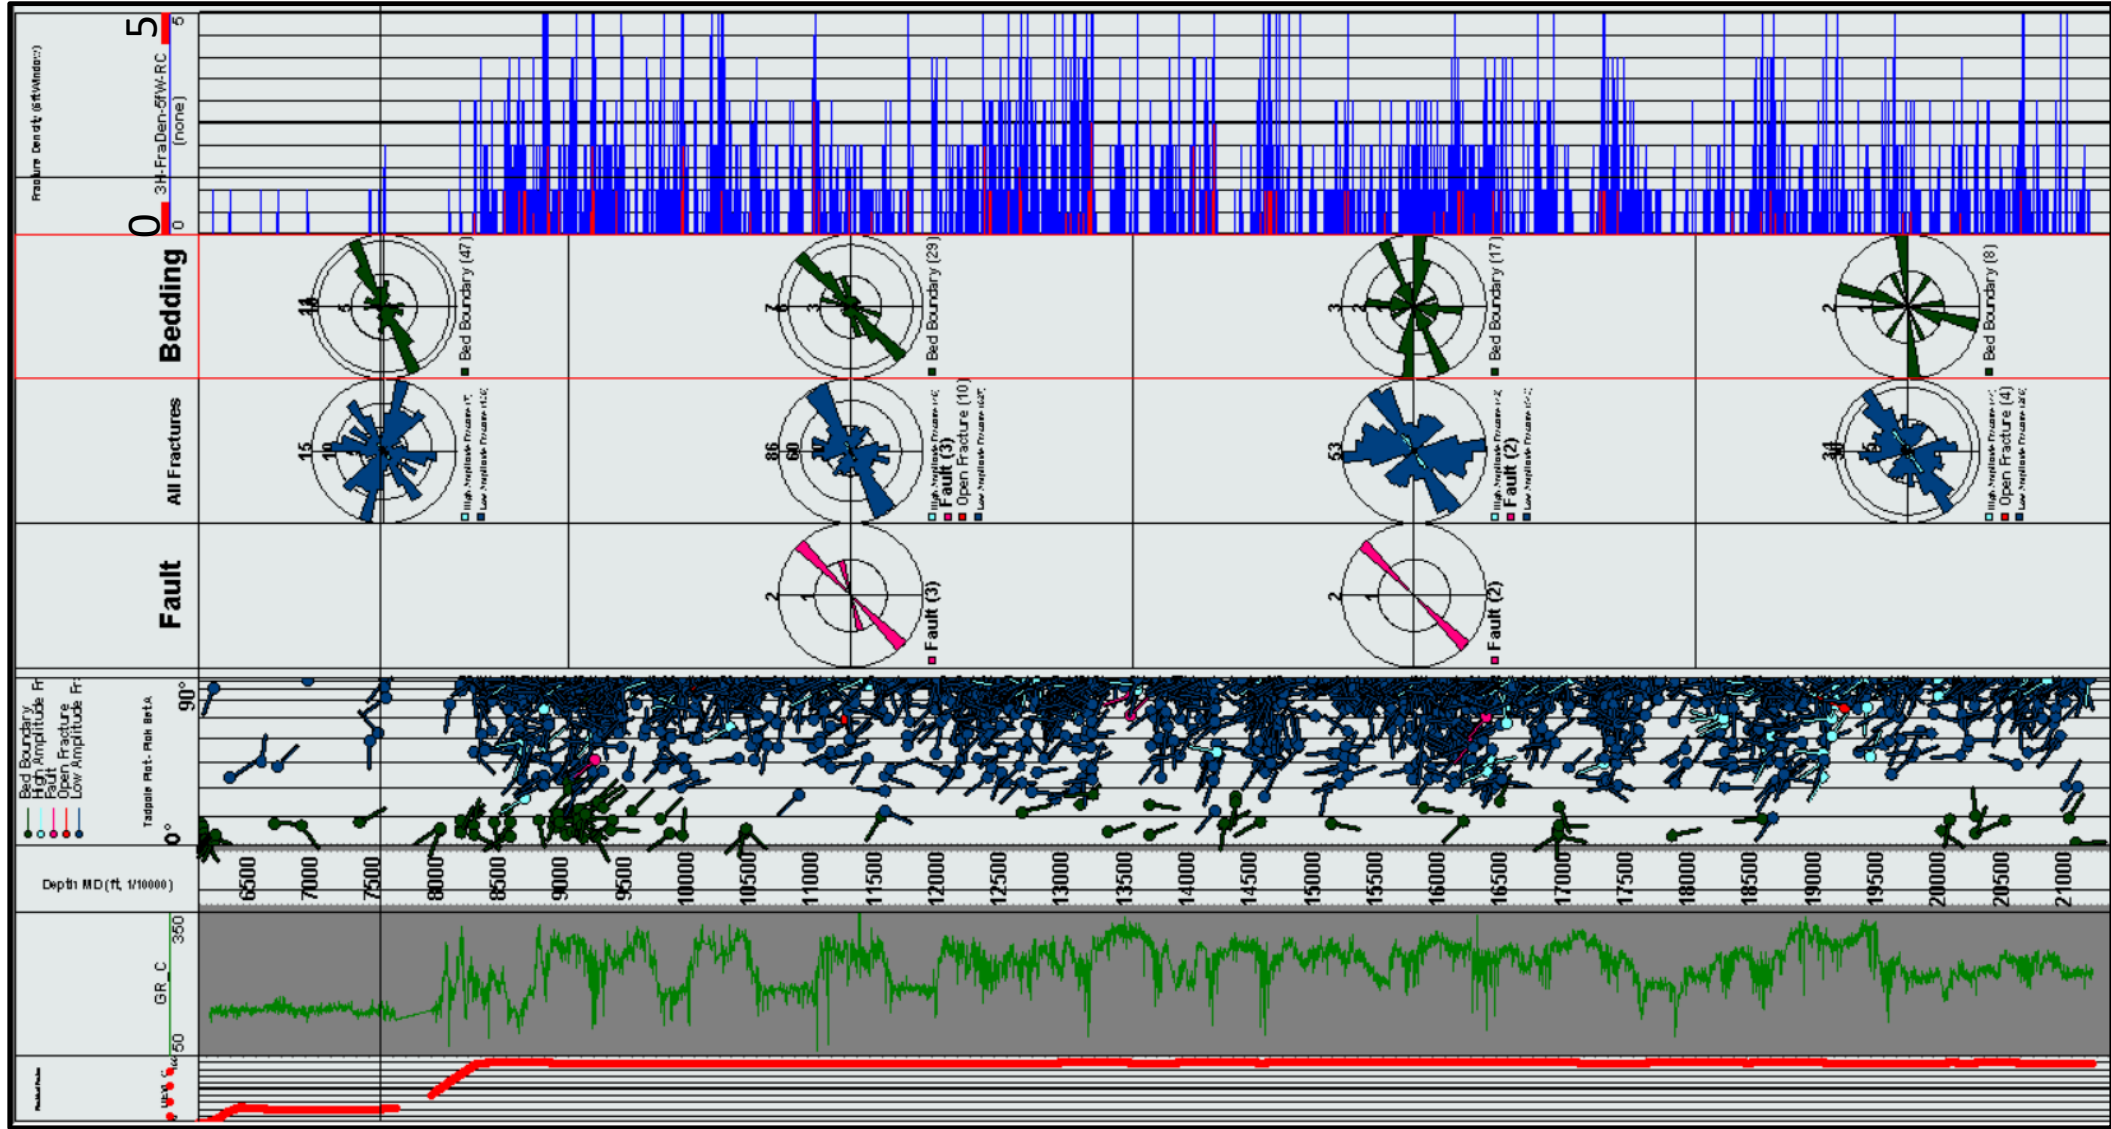
Fracture density along the wellbore – Boggess-3H (Horizontal view)

- Multiple fracture sets detected in the Marcellus laterals with a dominant set oriented at NE-SW and two secondary sets (sub-N-S and ESE-WSW);
- Fracture density is generally high in all wells but varied from well to well (3H & 13H highest and decreased in 5H and 9H) and also within any single lateral. It seems more fractures observed in organic material rich shale in general;

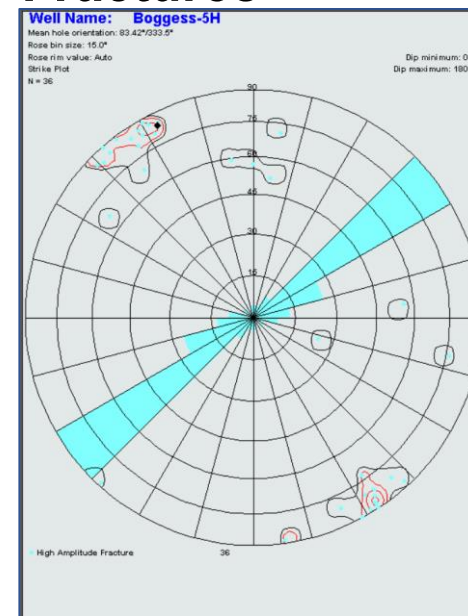
Fracture Summary – Boggess-5H

Fracture Type	#
Low amplitude fractures	1435
High amplitude fractures	36
Open fractures	4
Fault	0
Total	1475

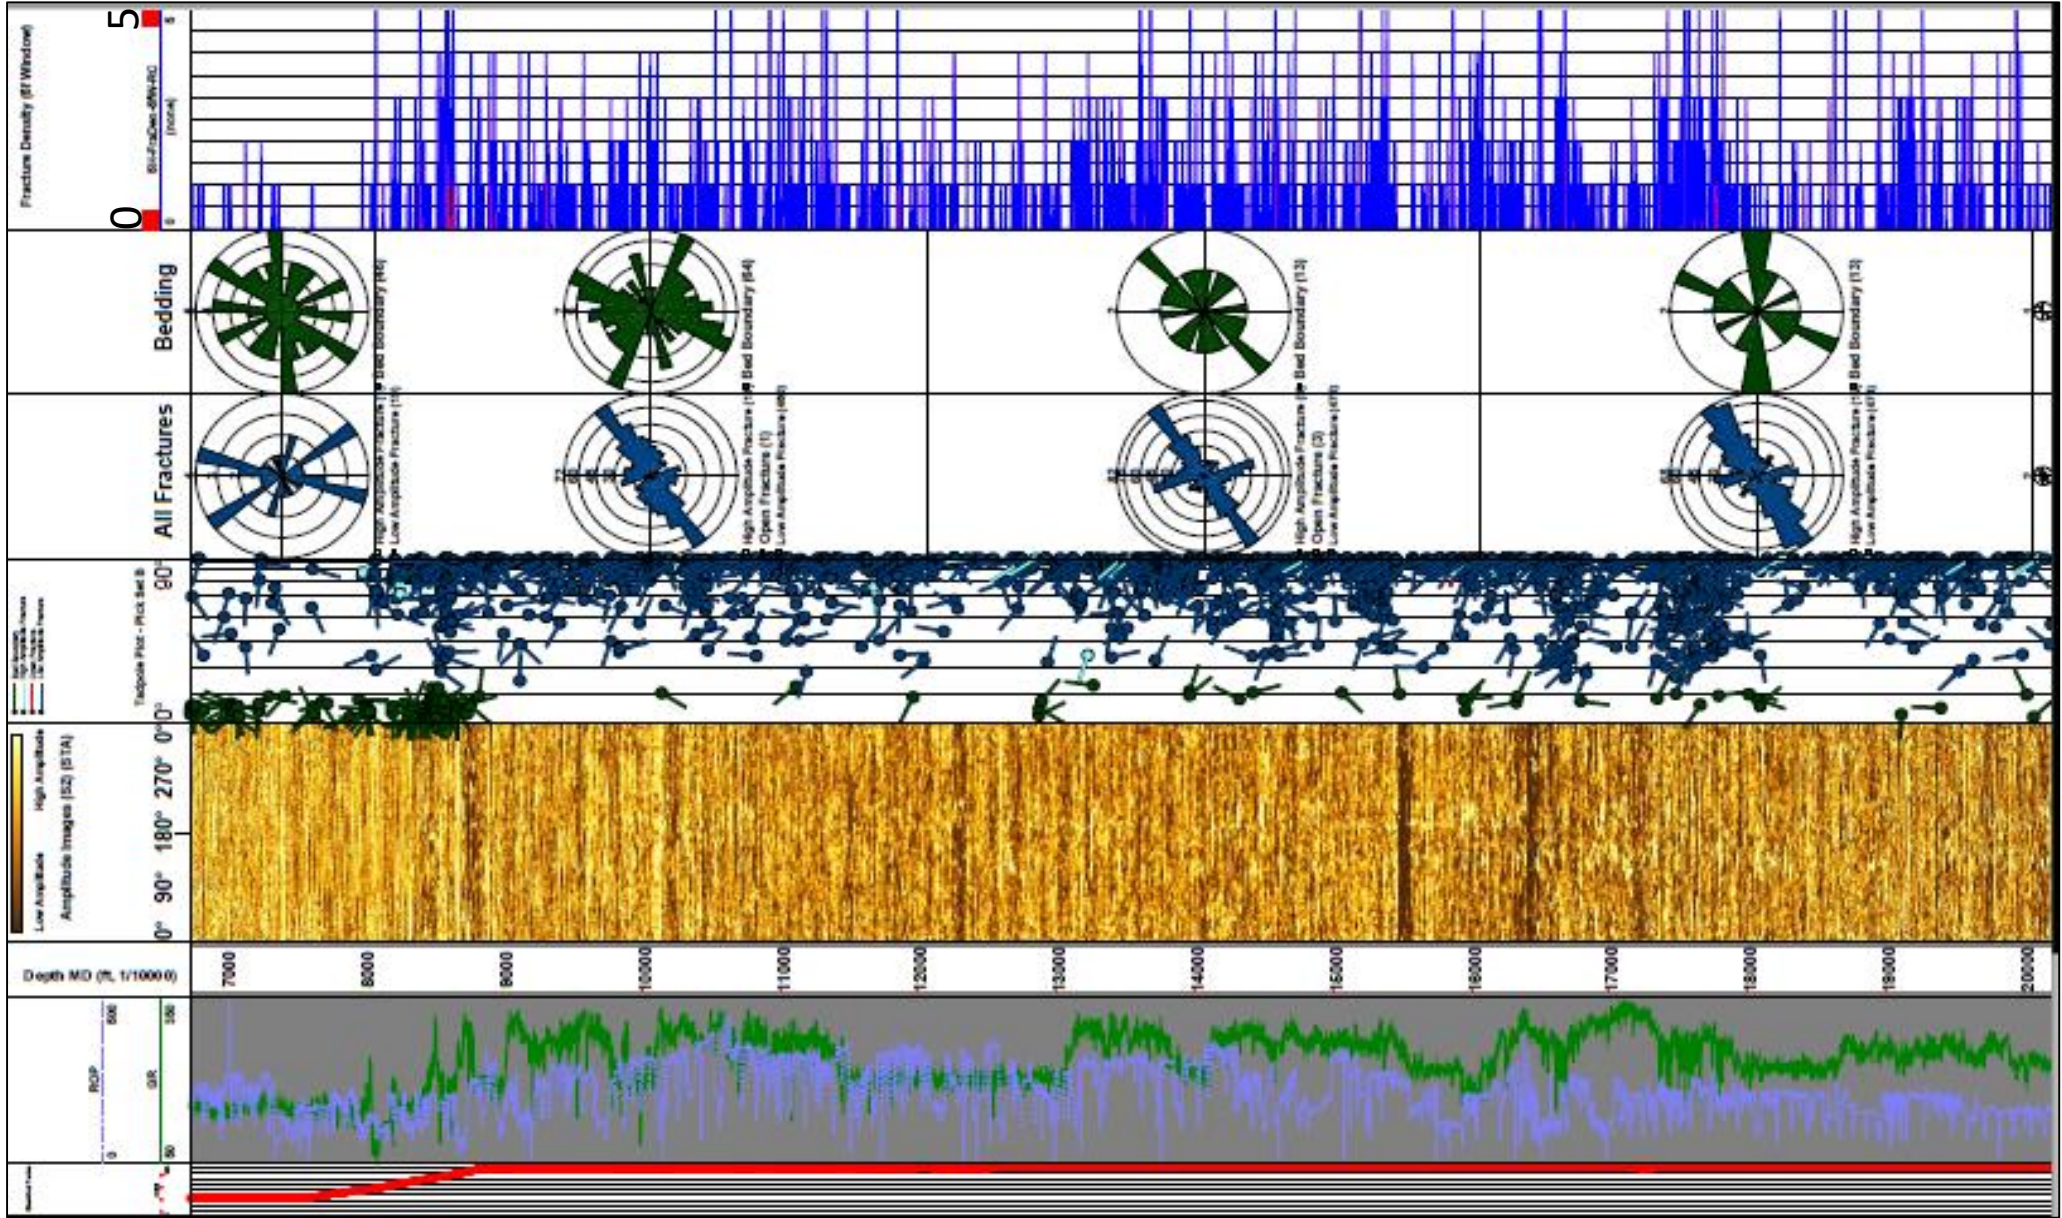
Fracture density along the wellbore - Boggess-5H

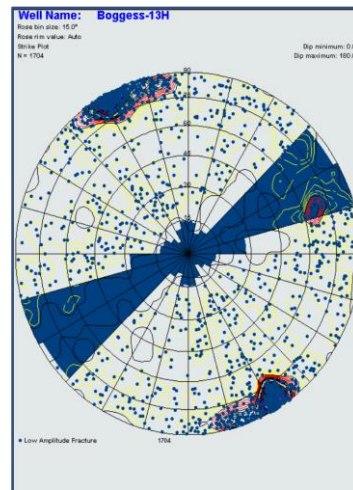
Rose diagram (strike plot) summary for each fracture/fault type – Boggess-13H

Fracture Type	#
Low amplitude fractures	1704
High amplitude fractures	32
Open fractures	1
Fault	1
Total	1738

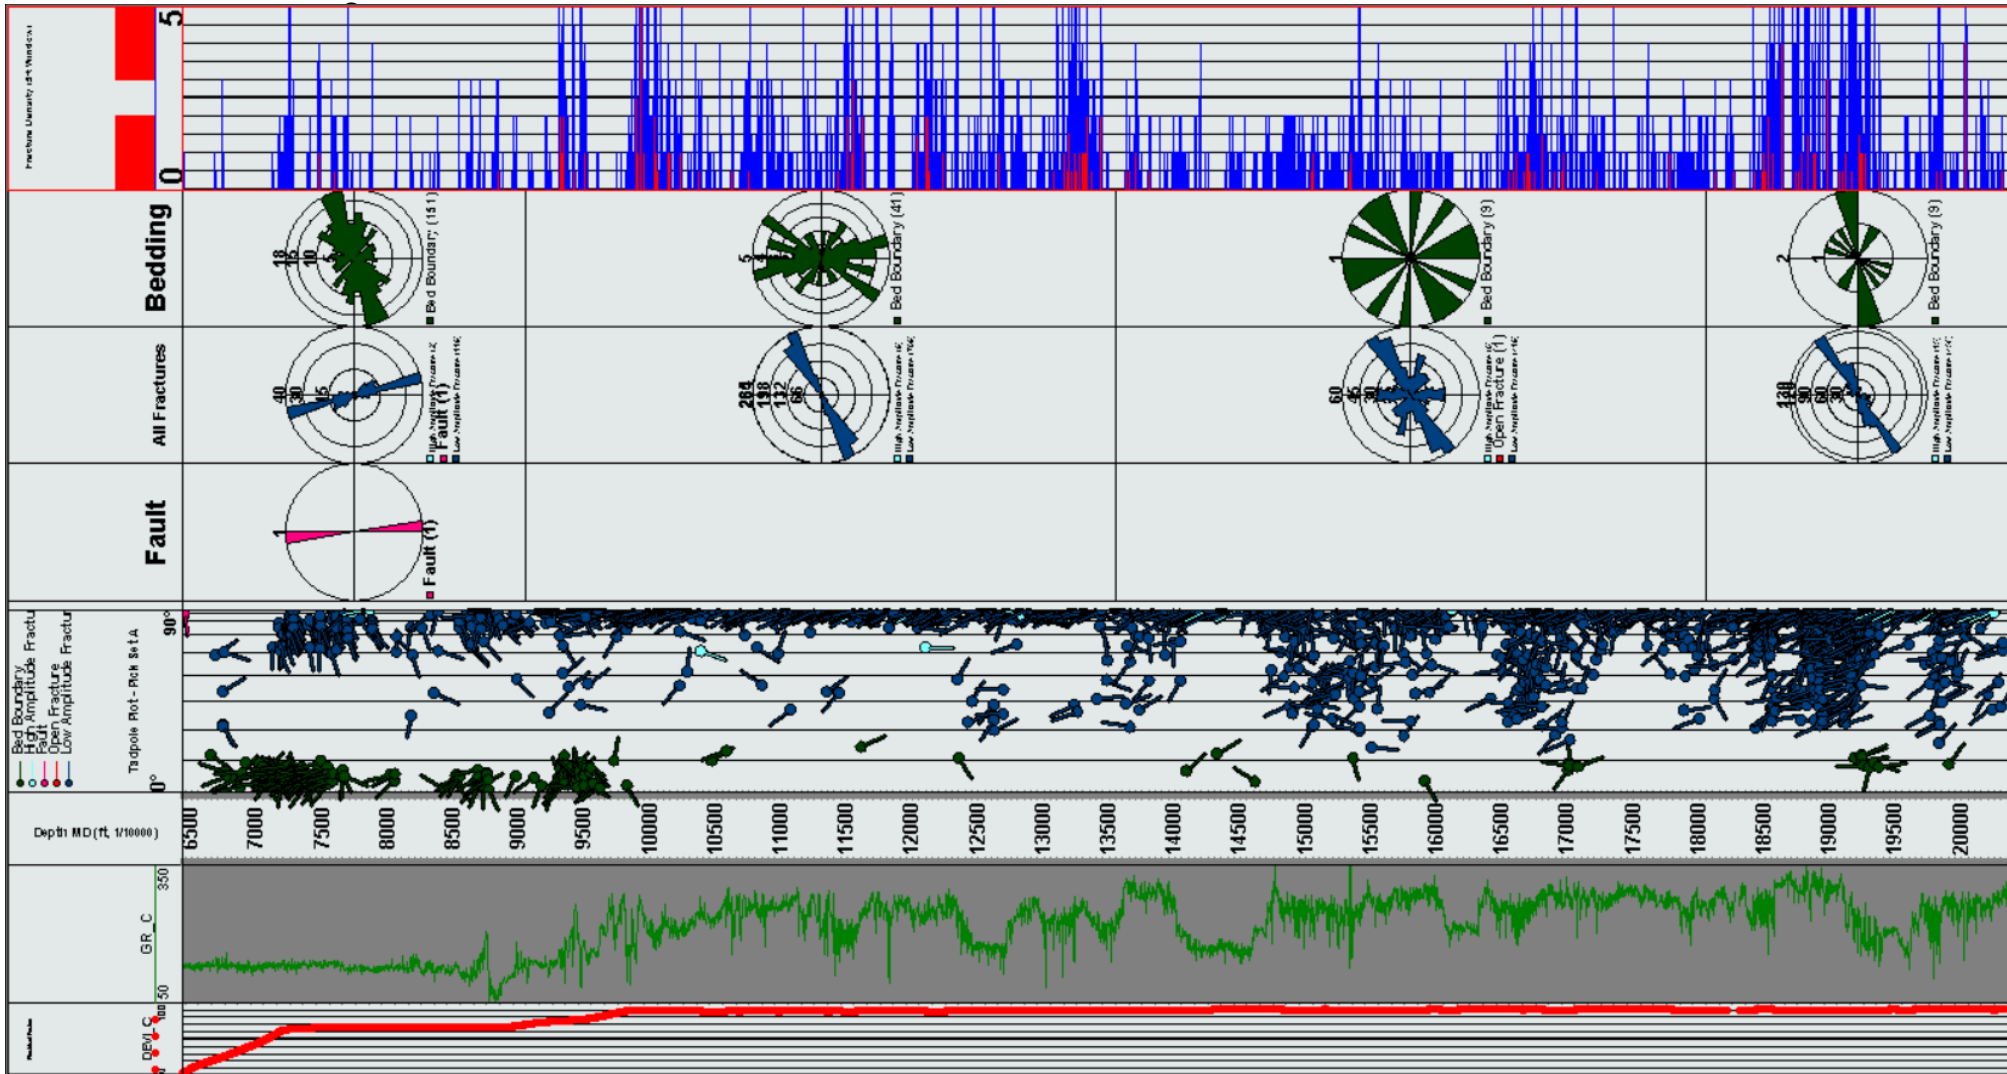
Fracture density along the wellbore – Boggess-13H

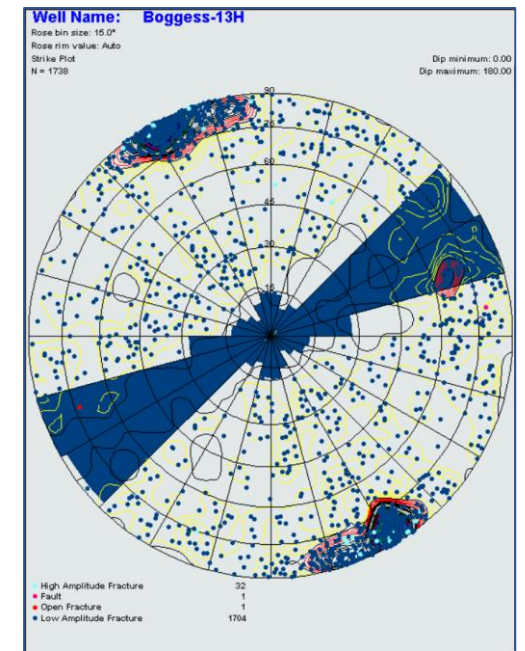
Fracture summary for all four wells

of total fractures: 1732

of total fractures: 1475

of total fractures: 1362

of total fractures: 1738

- Natural fractures are well-developed in the Marcellus & expected to impact stimulation;
- The total number of fractures interpreted for Boggess-3H, 5H, 9H and 13H is 1732, 1475, 1362 and 1738 respectively. Majority of them are low amplitude fractures for all wells;
