Fracture Interpretation Summary – Boggess-5H

(Preliminary version, date July-9th-2019)

Well Name: Boggess-5H

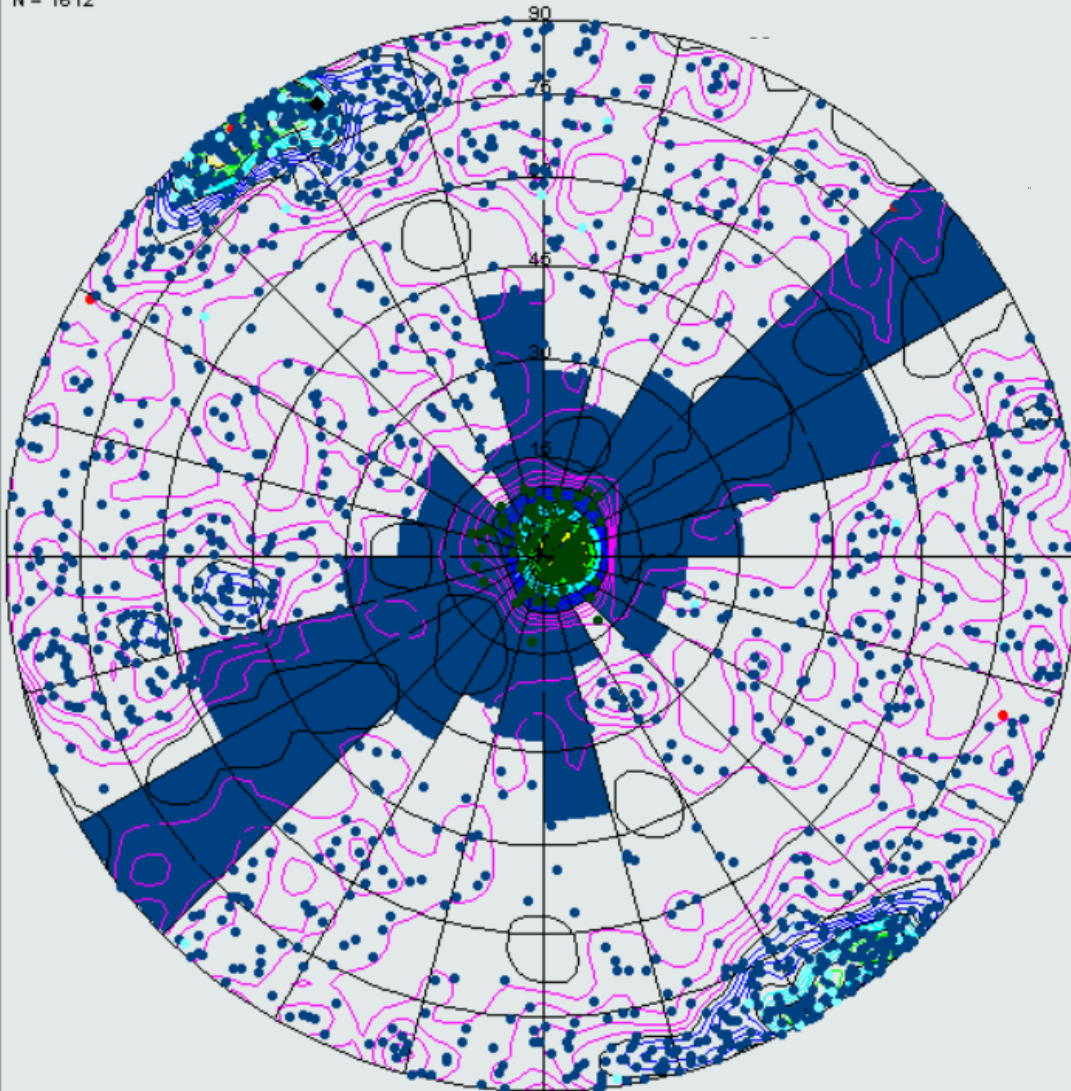
Mean hole orientation: 83.42°/333.5°

Rose bin size: 15.0°

N = 1612

**Rose diagram (strike plot)
summary for all fractures,
faults and bedding dip**

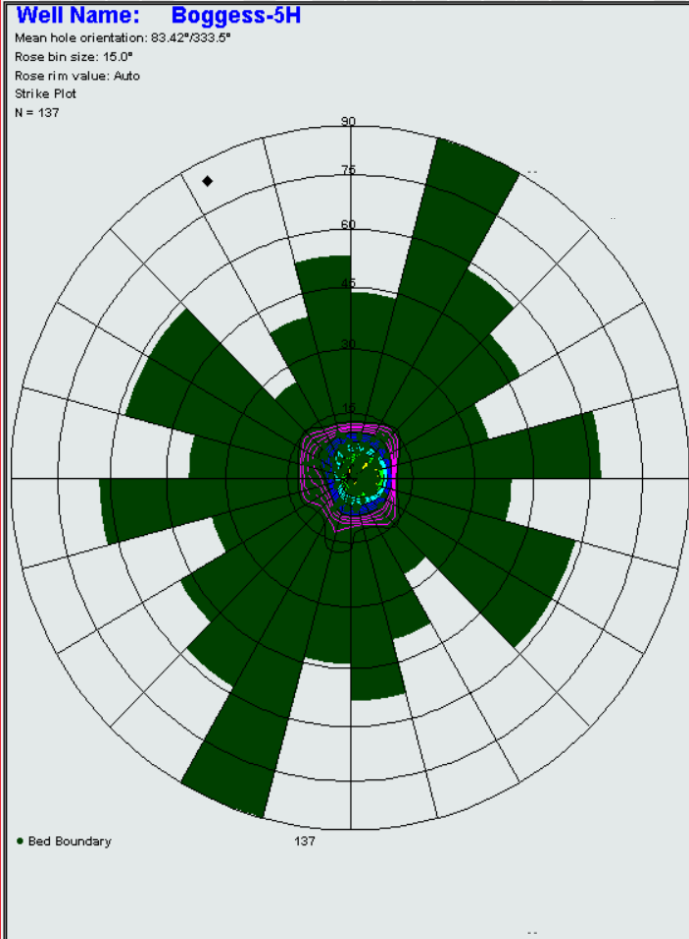
Rose diagram (strike plot) summary for all bedding dips

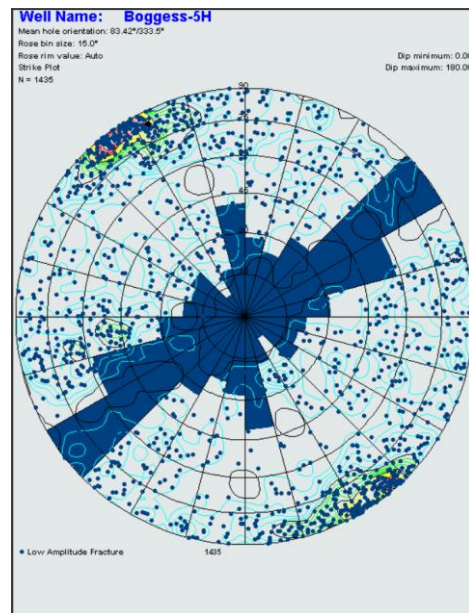
Low Amplitude Fractures

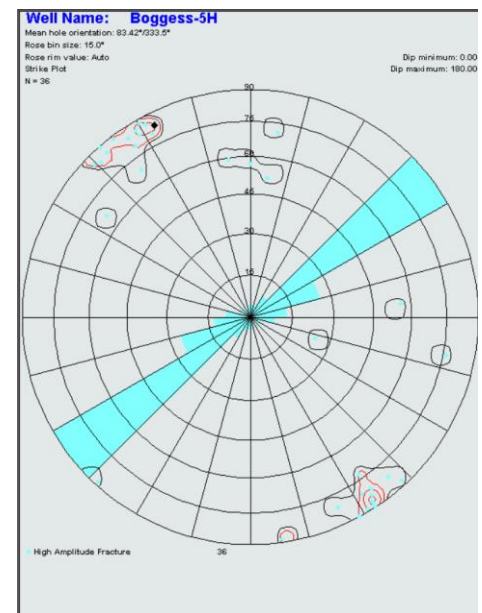
High Amplitude Fractures

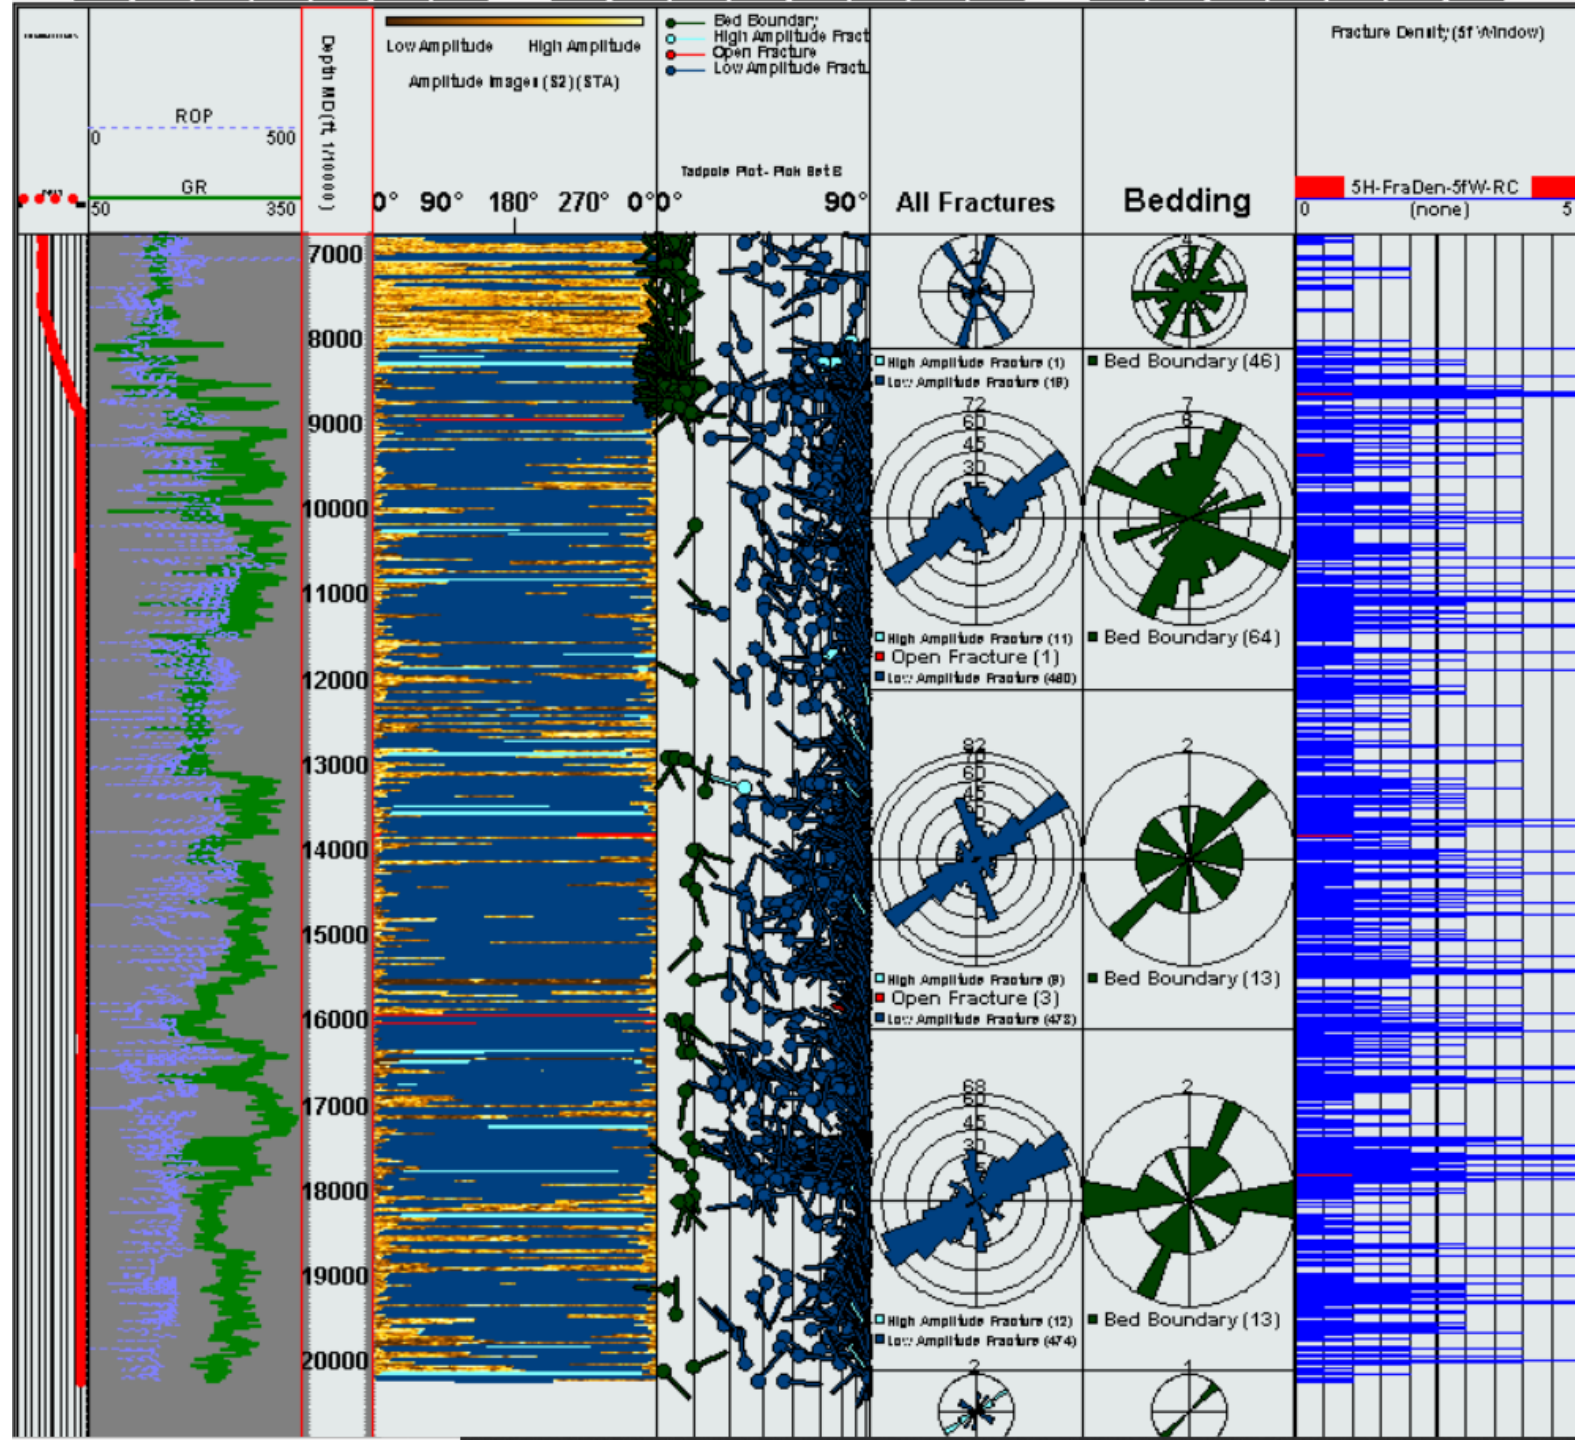
**Fracture density
along the wellbore
(vertical presentation view)**

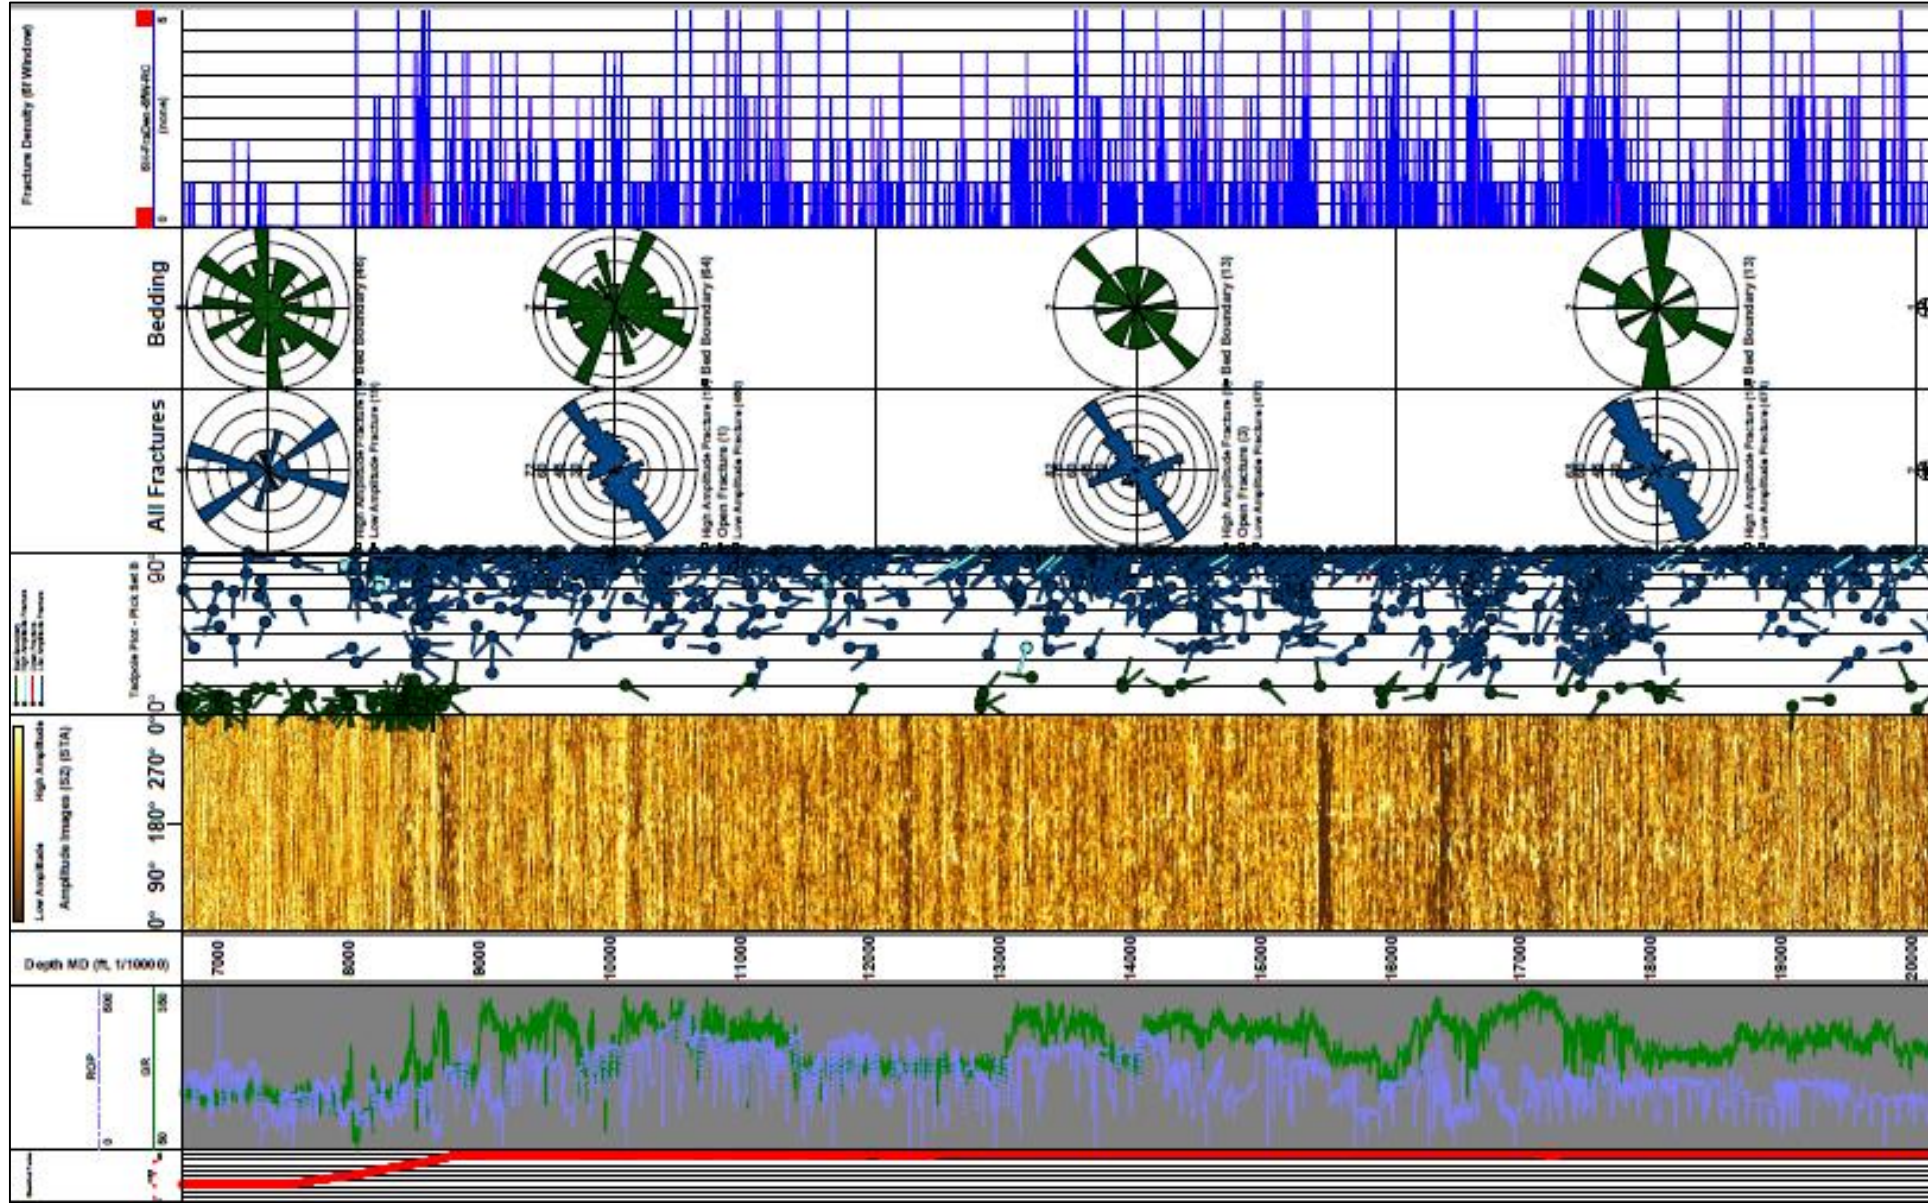
Fracture density along the wellbore

(Horizontal presentation view)

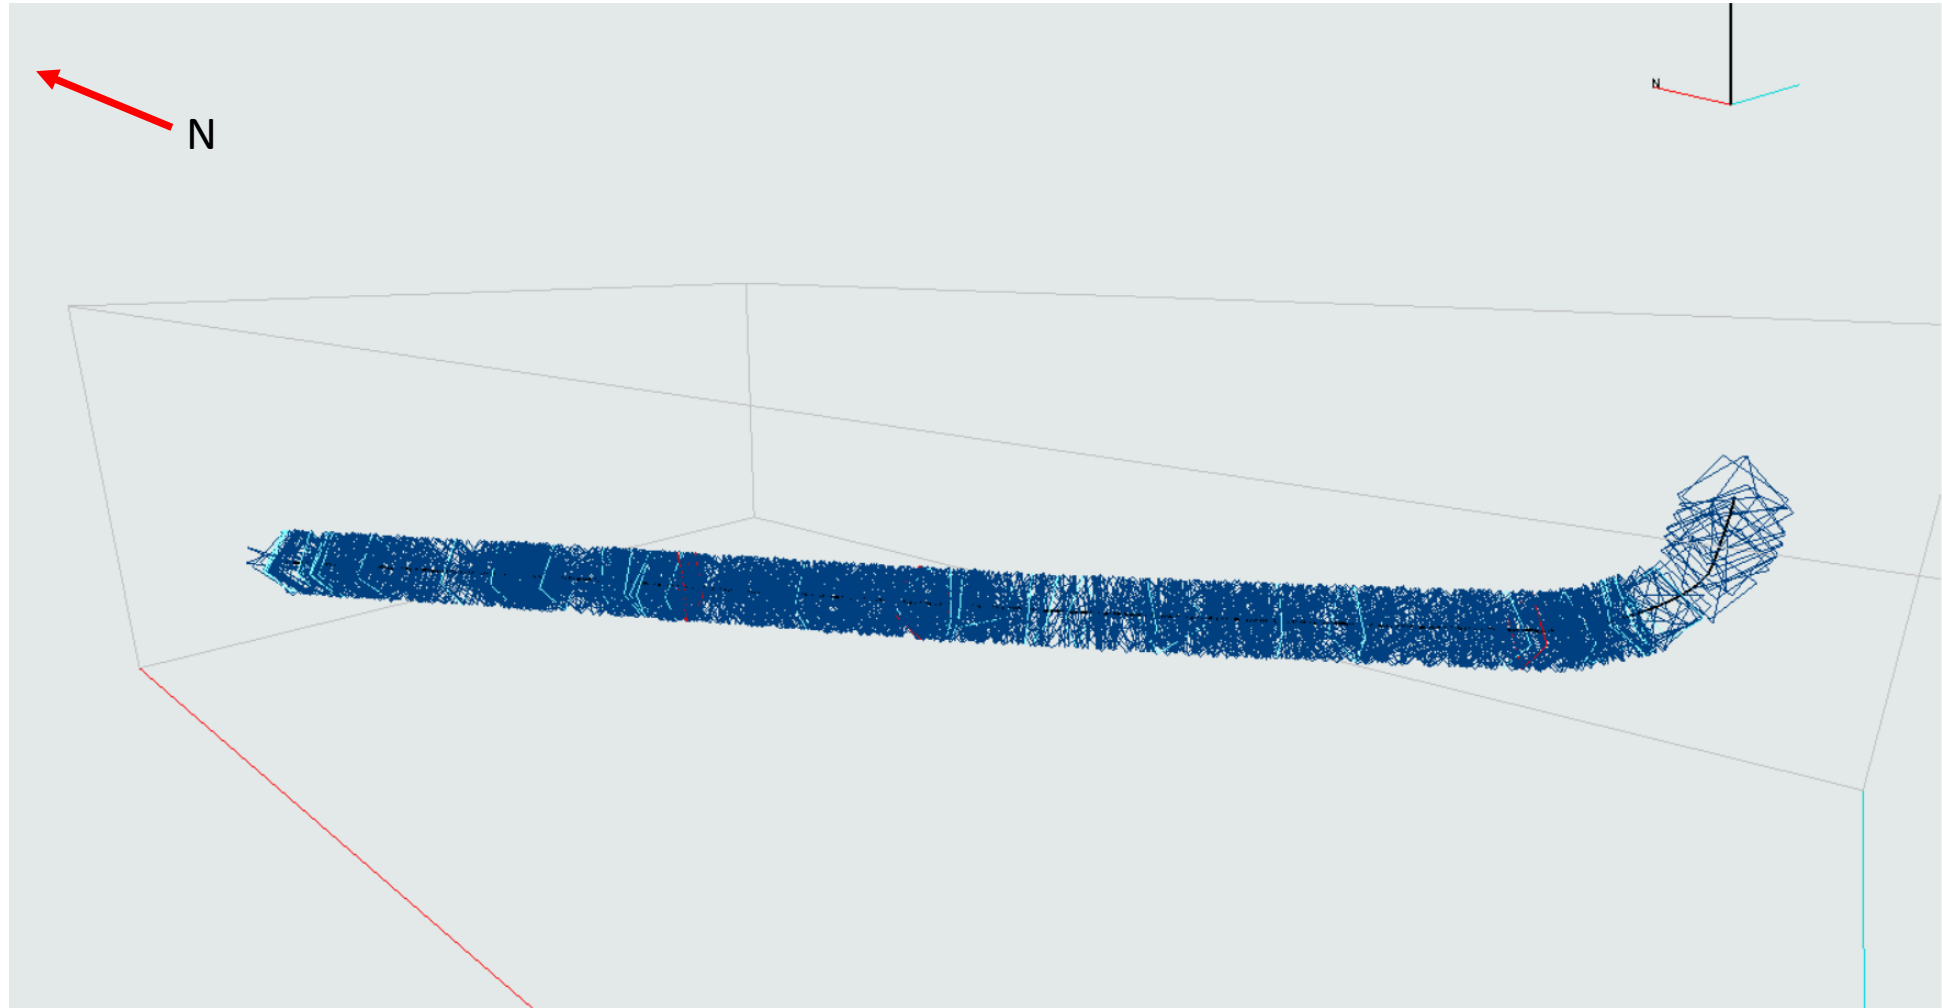
3-D view of all fractures and faults along wellbore – Boggess-5H
