Fracture Interpretation Summary – Boggess-9H

(Preliminary version, date July-9th-2019)

Well Name: Boggess-9H

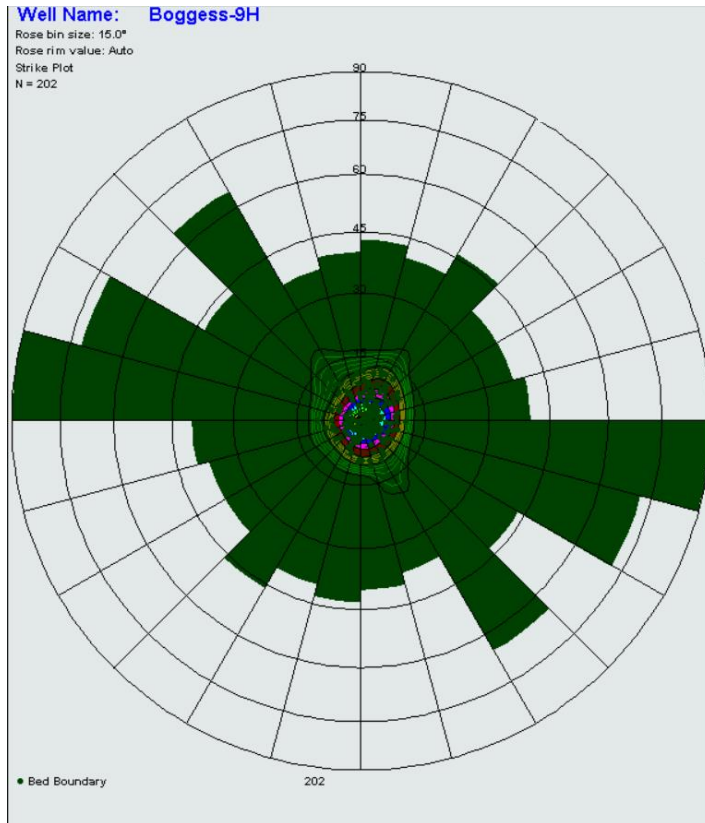
Rose diagram (strike plot) summary for all bedding dips

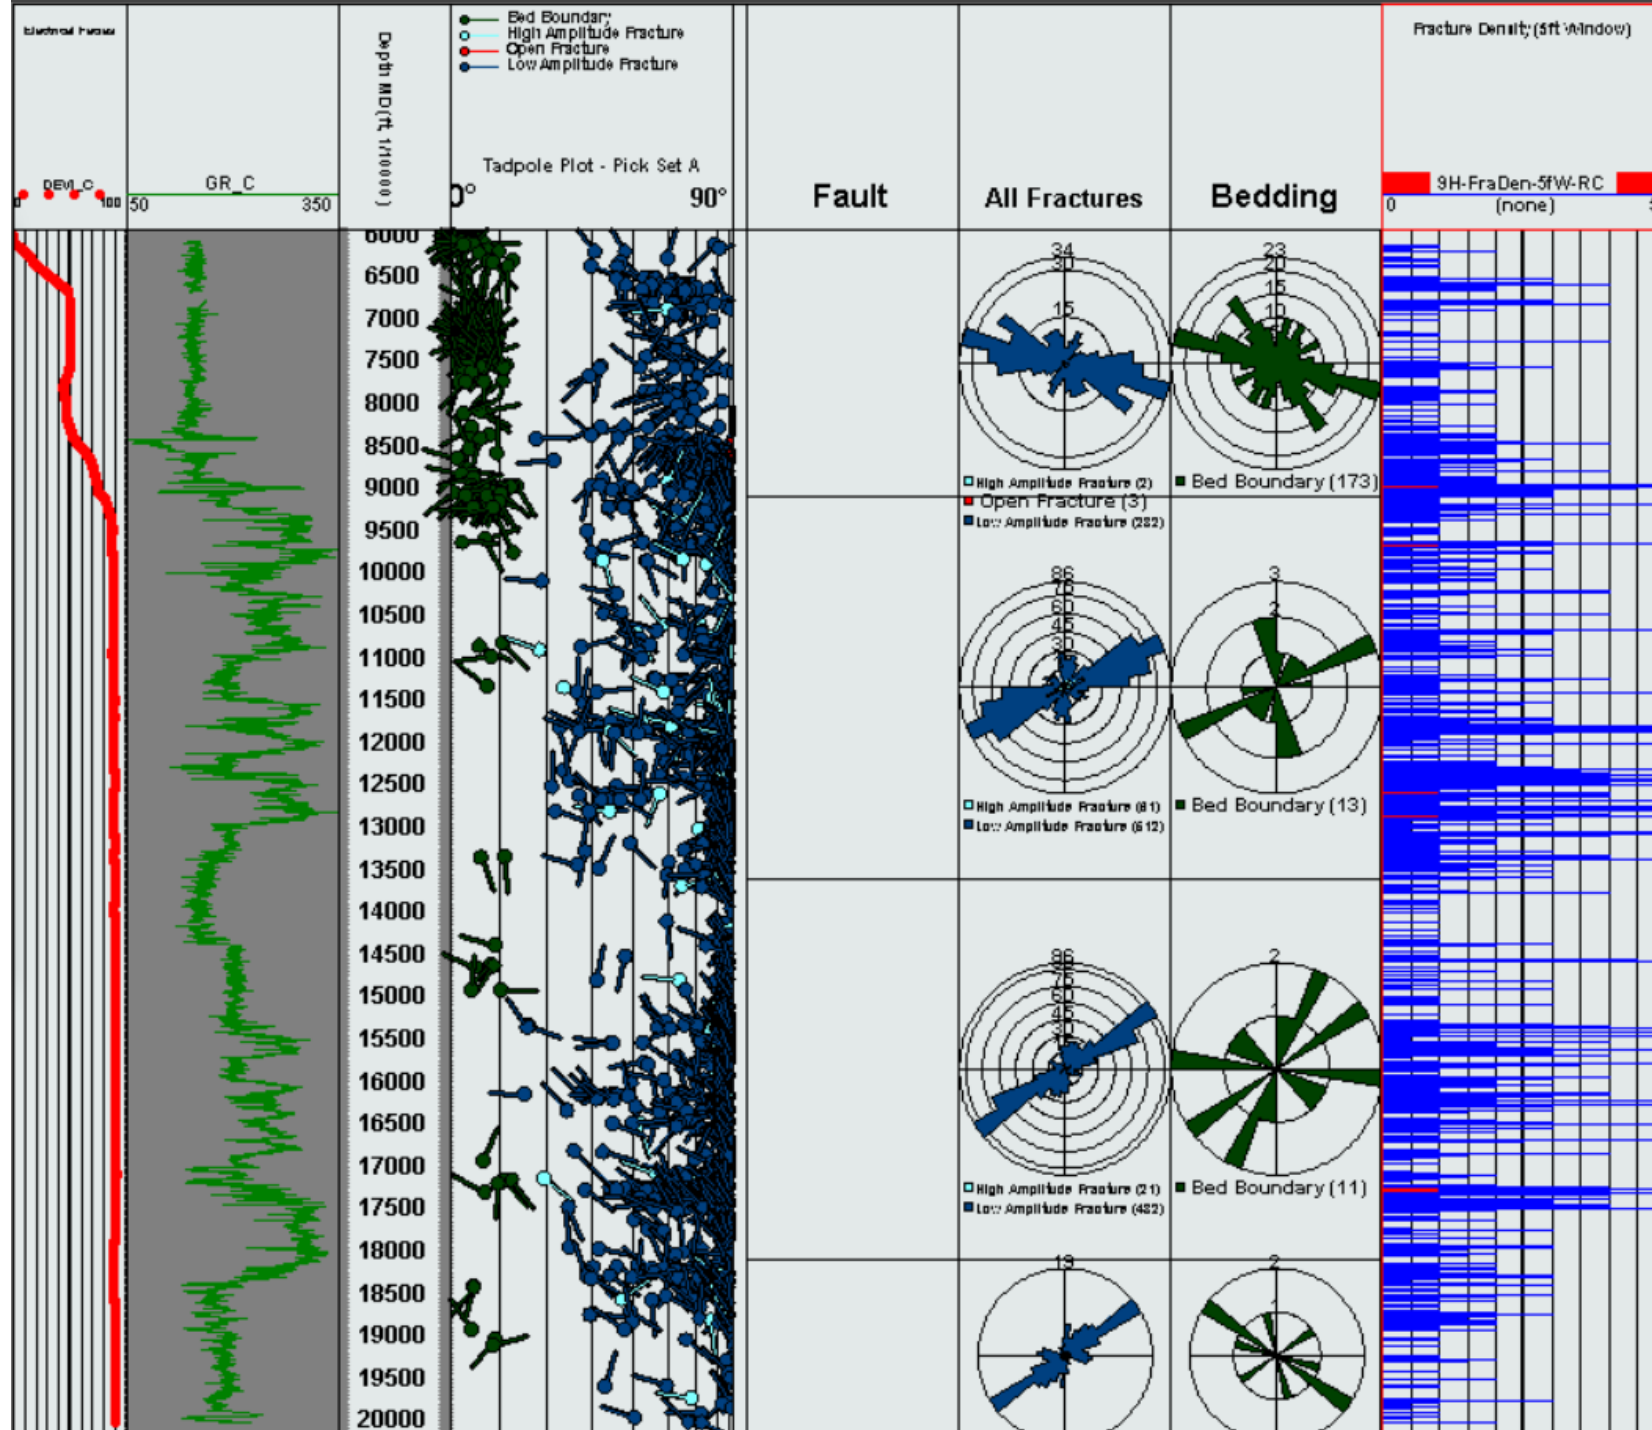
Fracture density along the wellbore
(vertical presentation view)

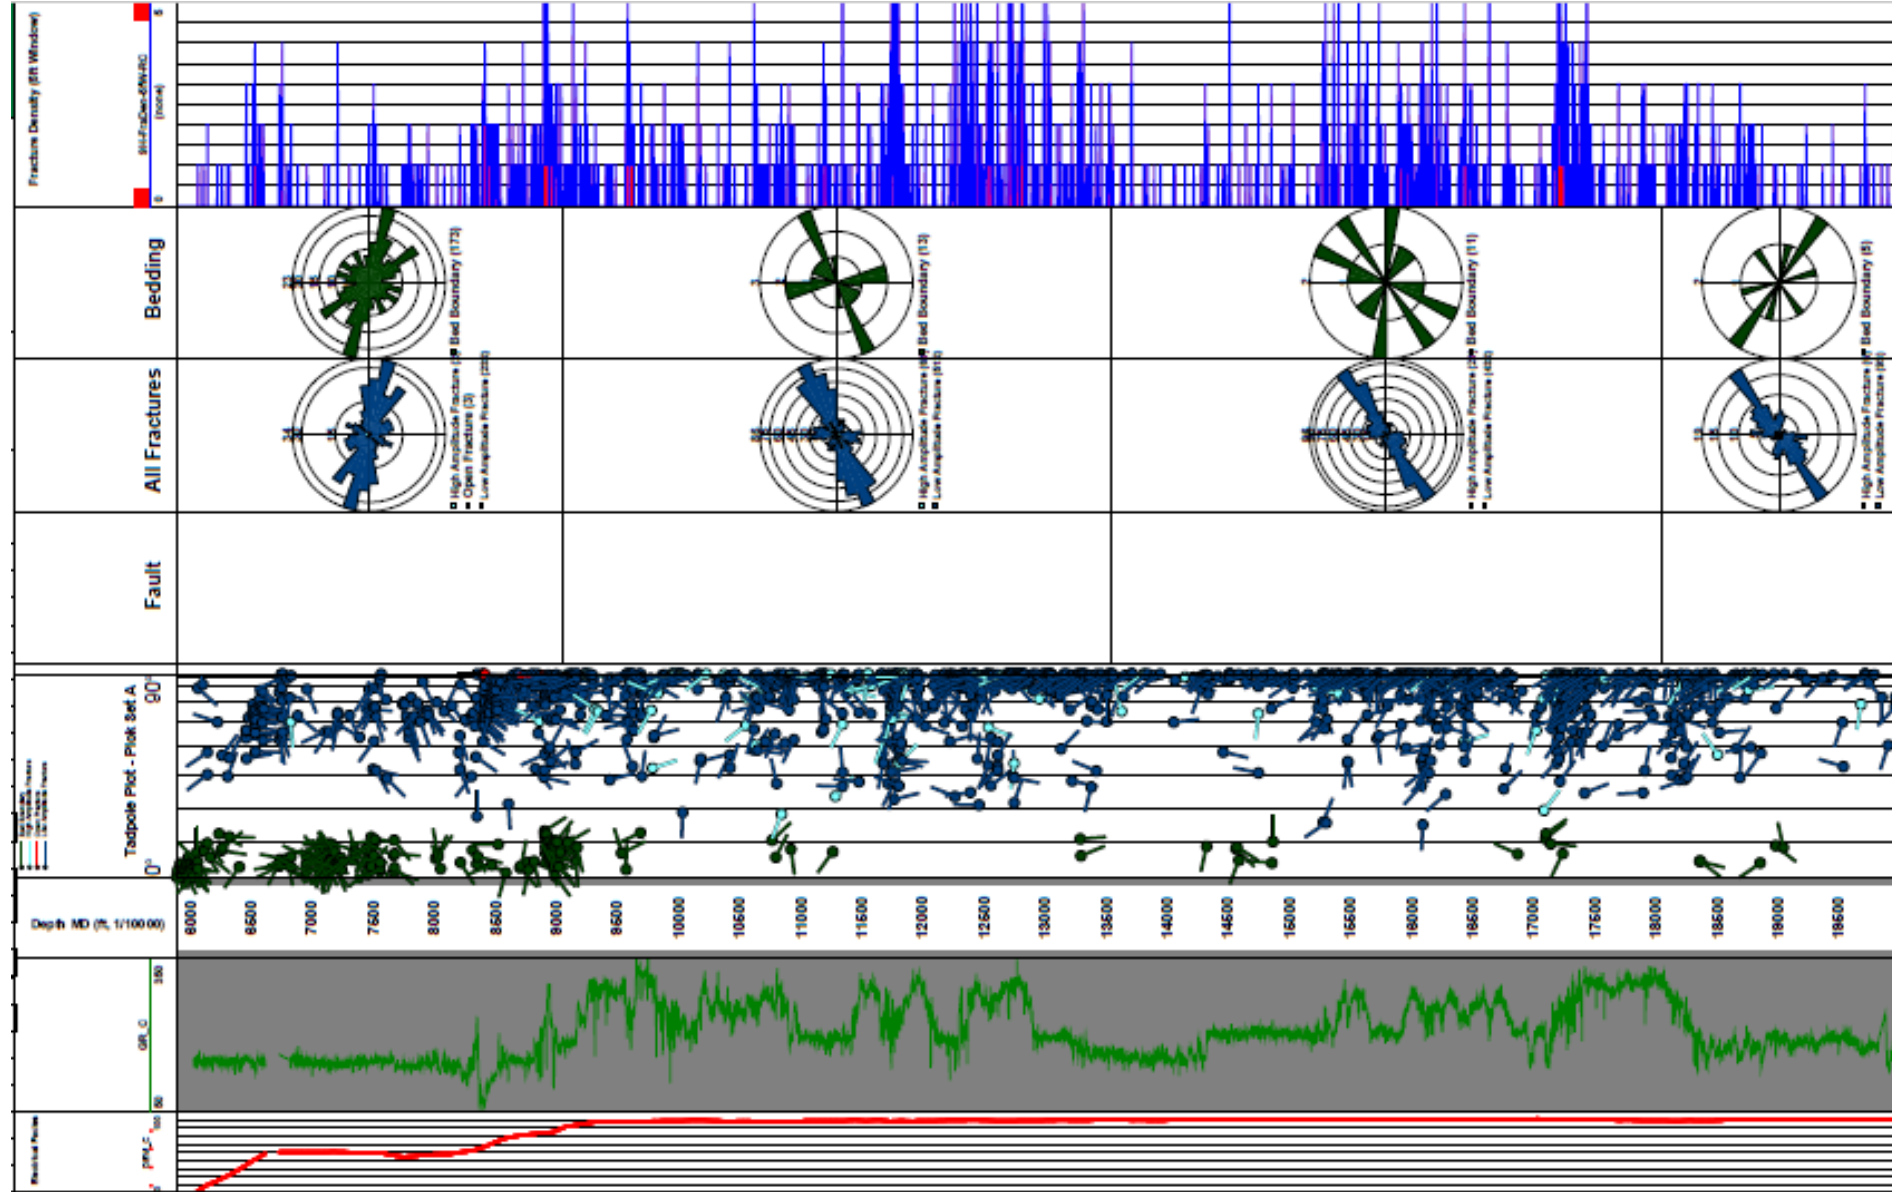
Fracture density along the wellbore

(Horizontal presentation view)

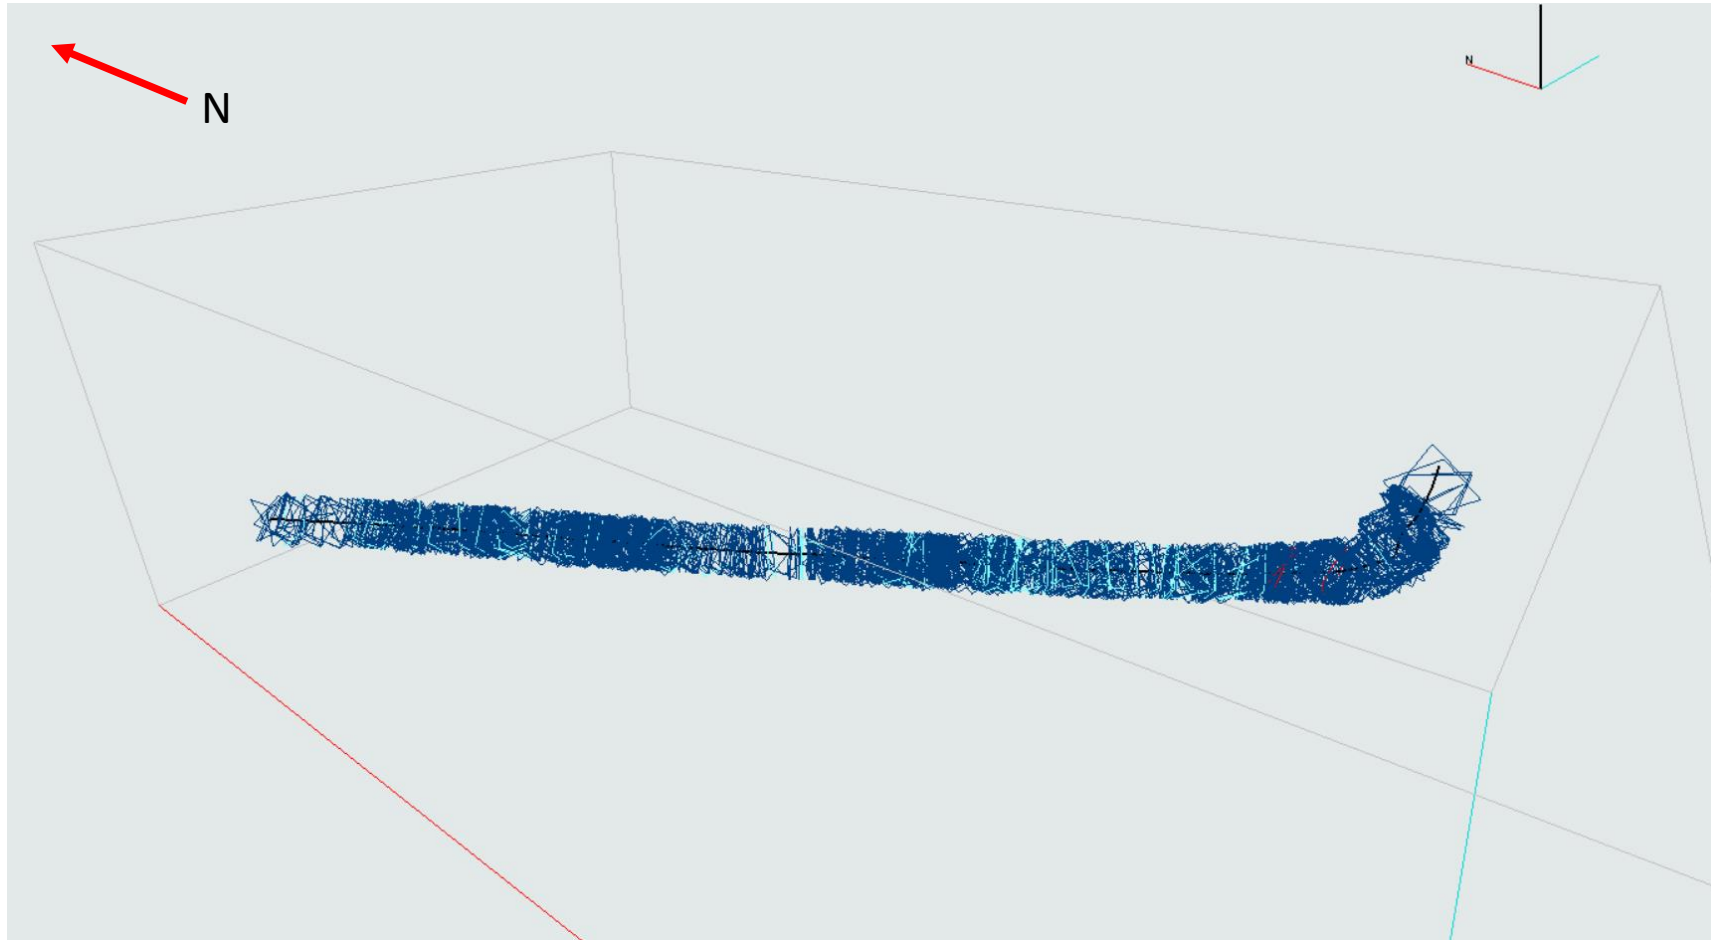
3-D view of all fractures and faults along wellbore – Boggess-9H
