Fracture Interpretation Summary – Boggess-3H

(Preliminary version, date July-8th-2019)

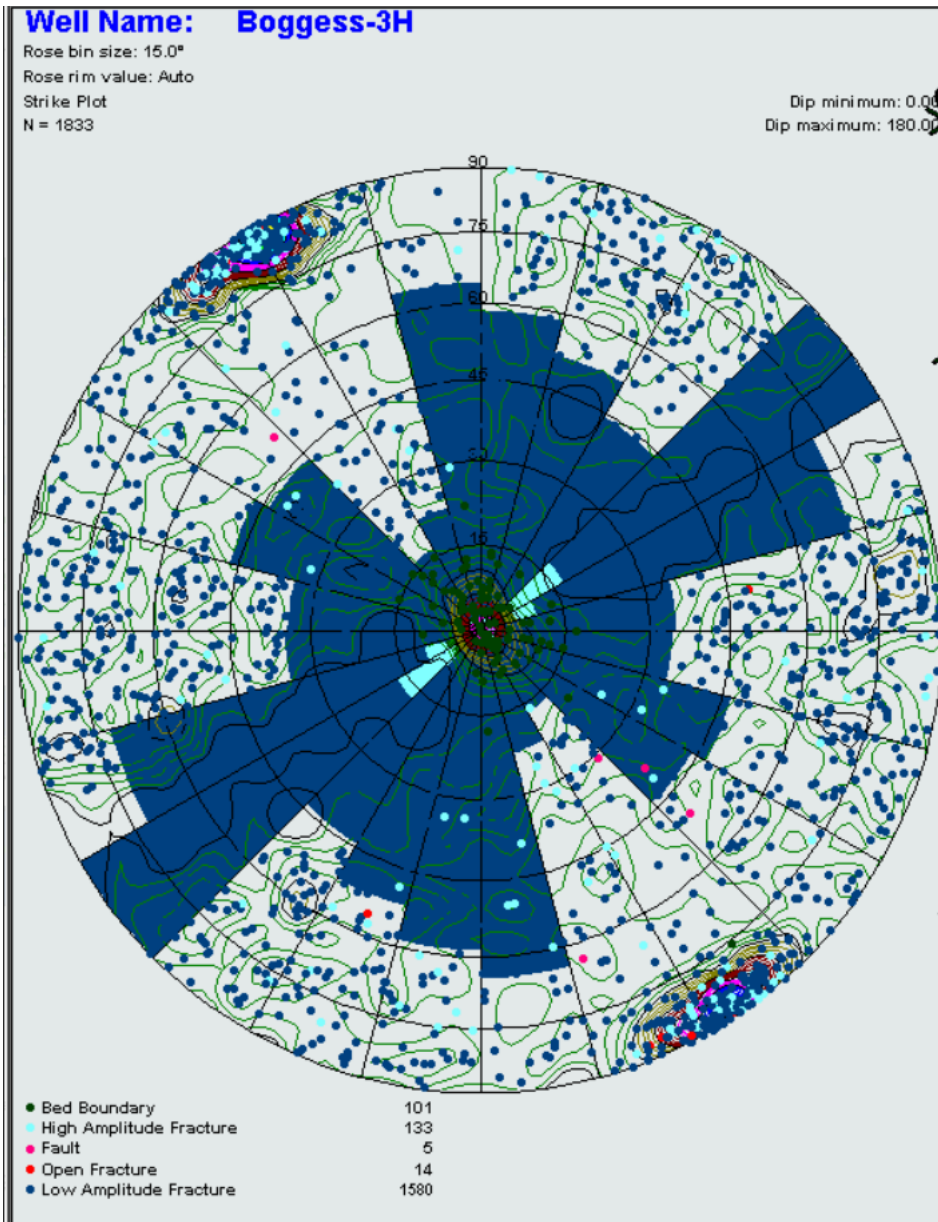
**Rose diagram (strike plot)
 summary for all fractures,
 faults and bedding dip**

**Total number of features
 interpreted in the entire well**

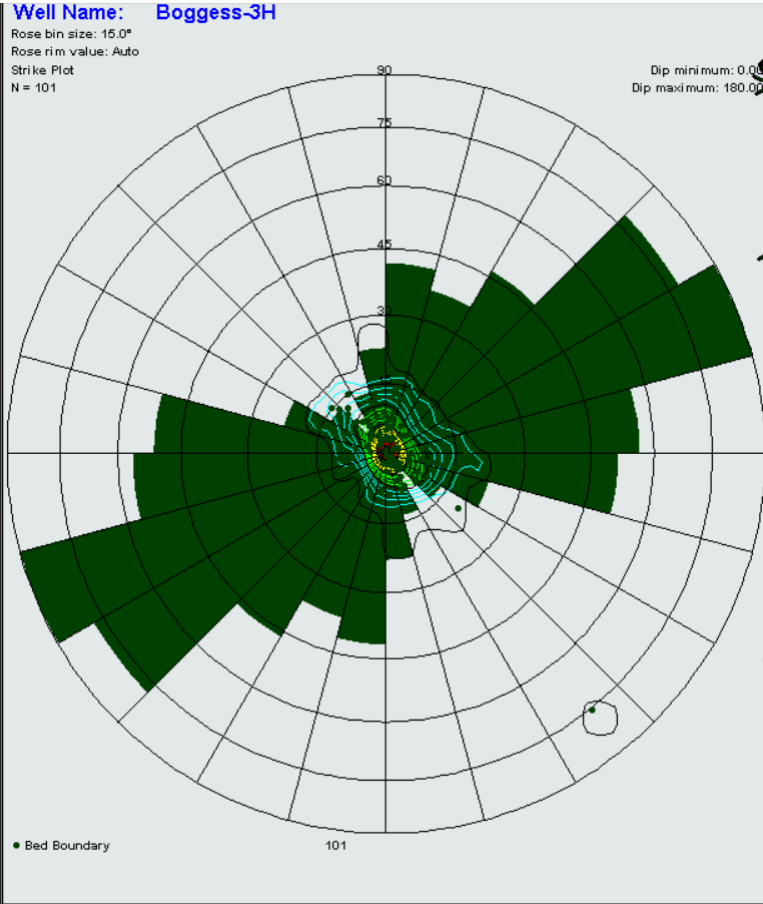
Rose diagram (strike plot) summary for all bedding dips

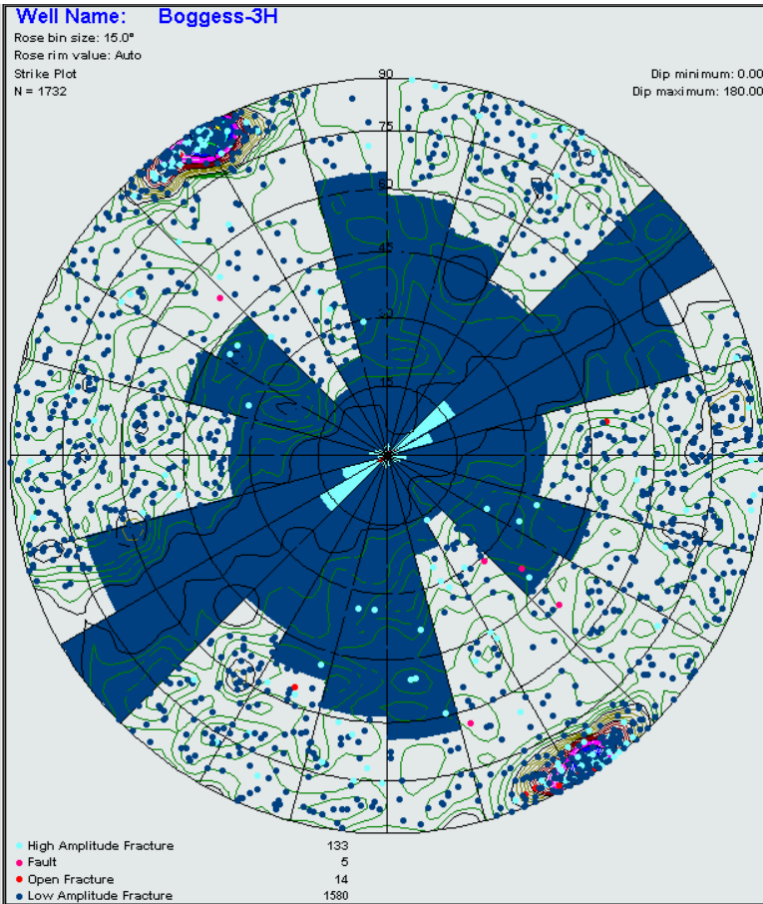
Rose diagram (strike plot) summary for all fracture/fault dips

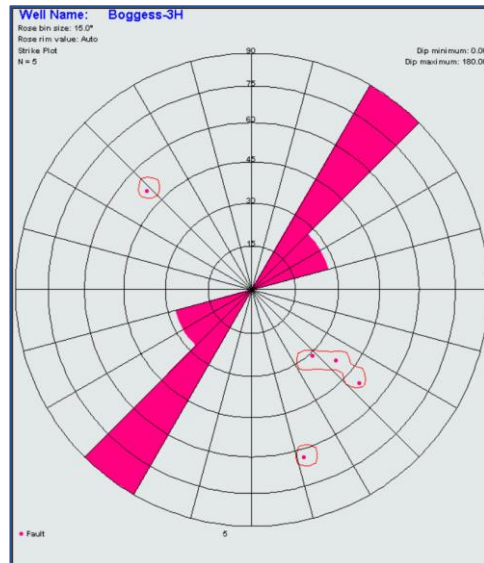
Fault

Rose diagram (strike plot) summary for each fracture/fault type

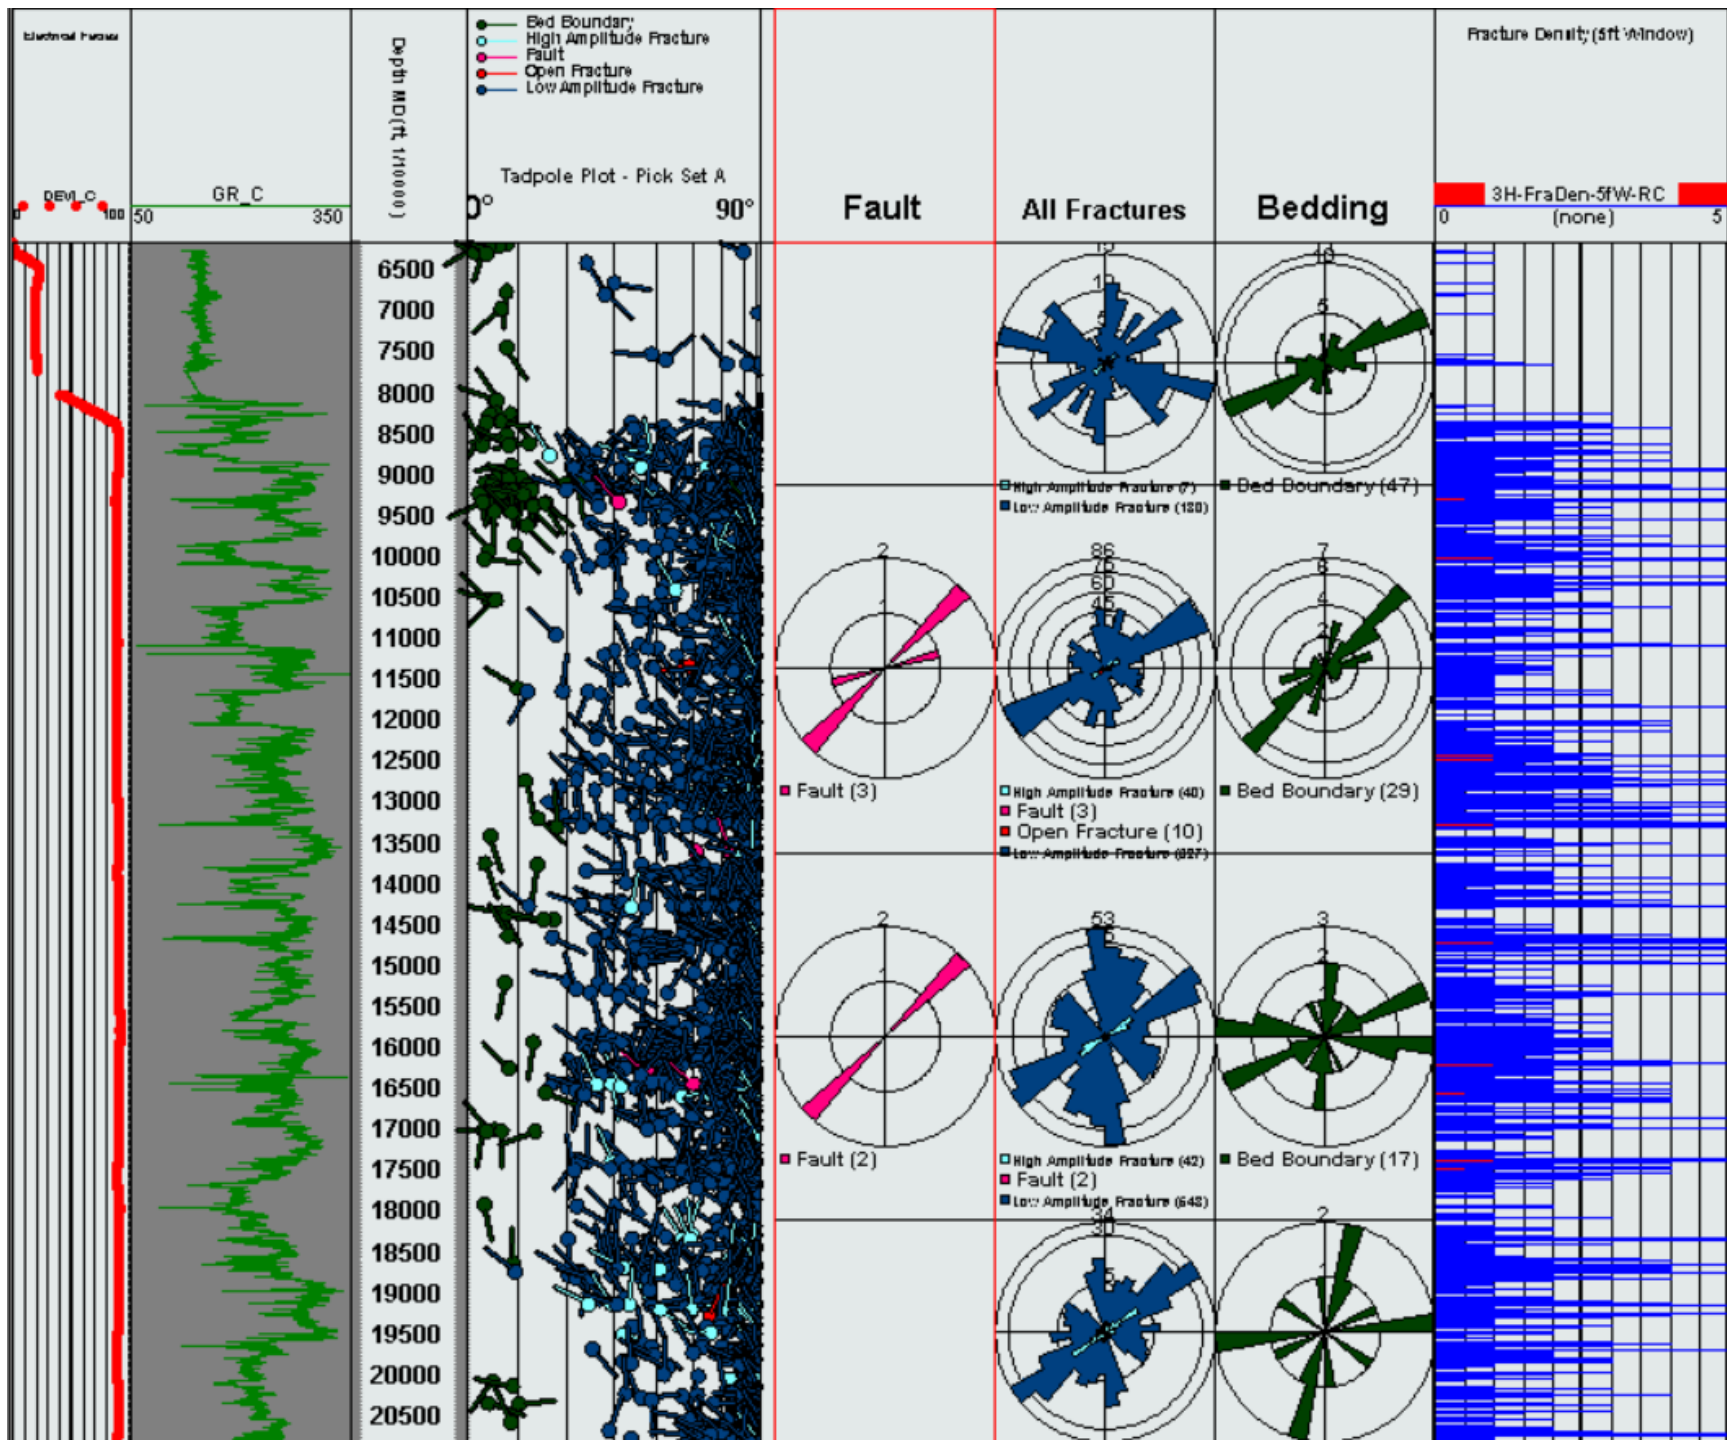
**Fracture density
along the wellbore**
(vertical presentation view)

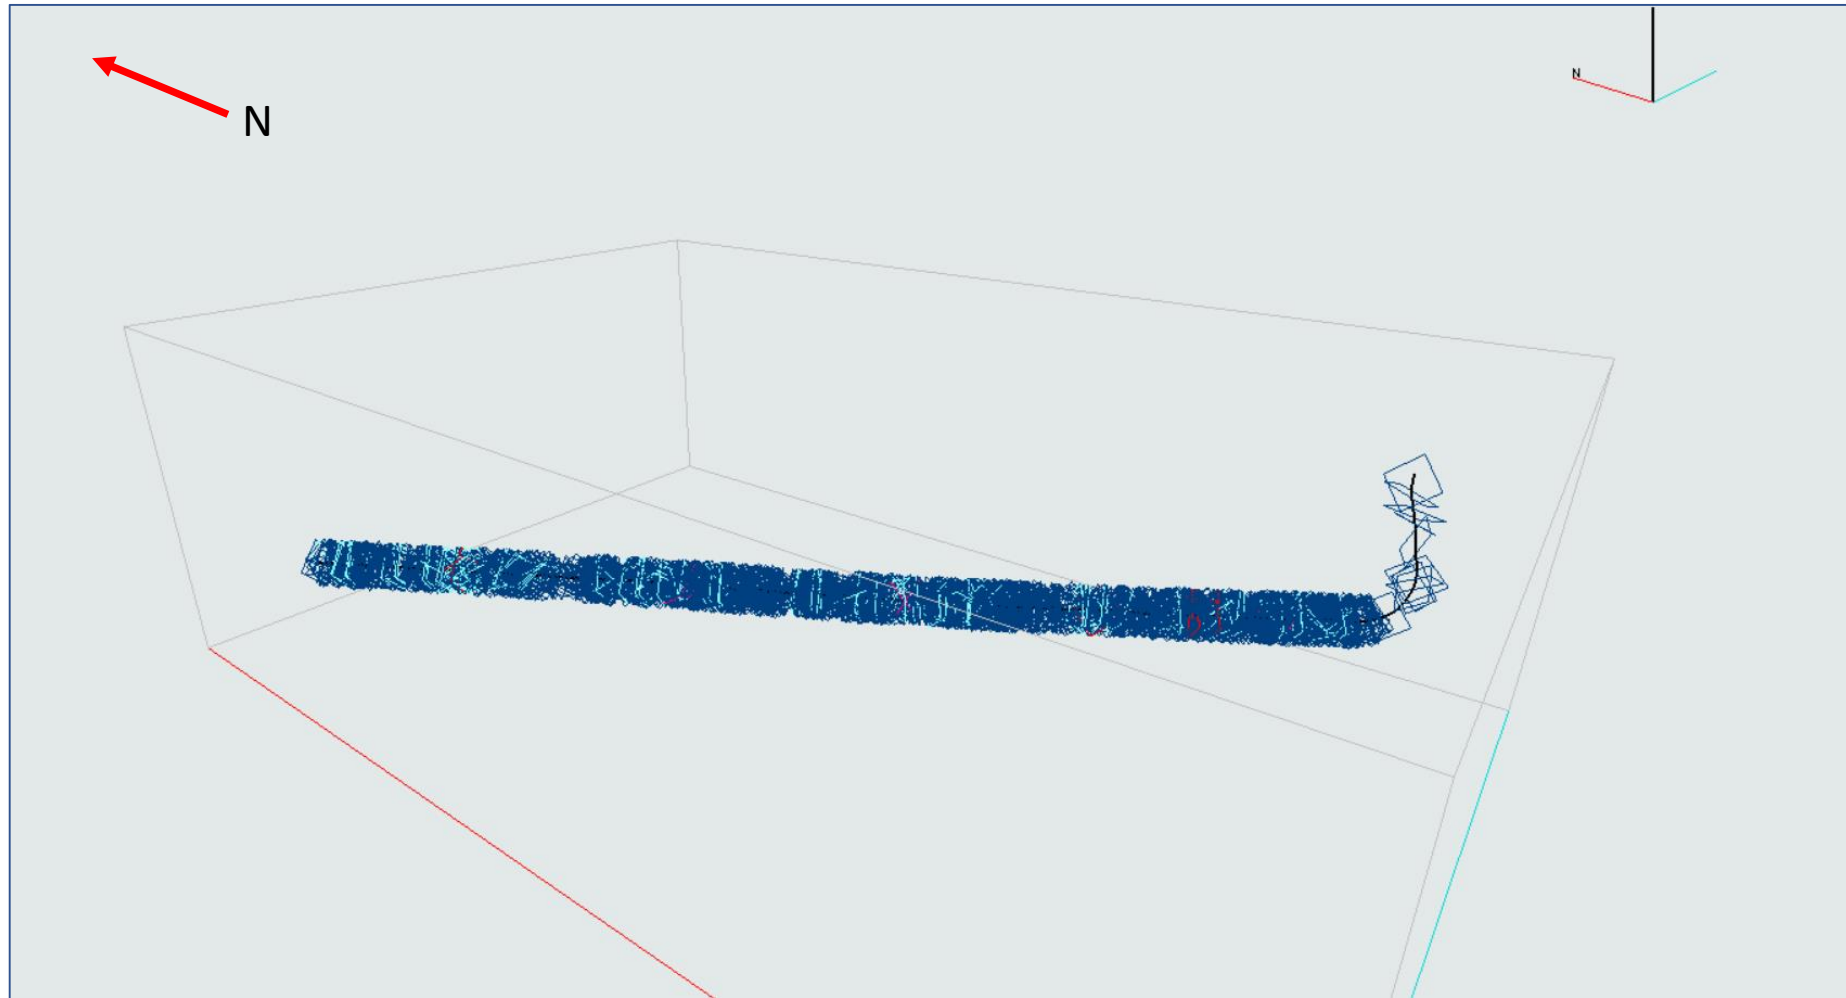
3-D view of all fractures and faults along wellbore – Boggess-3H

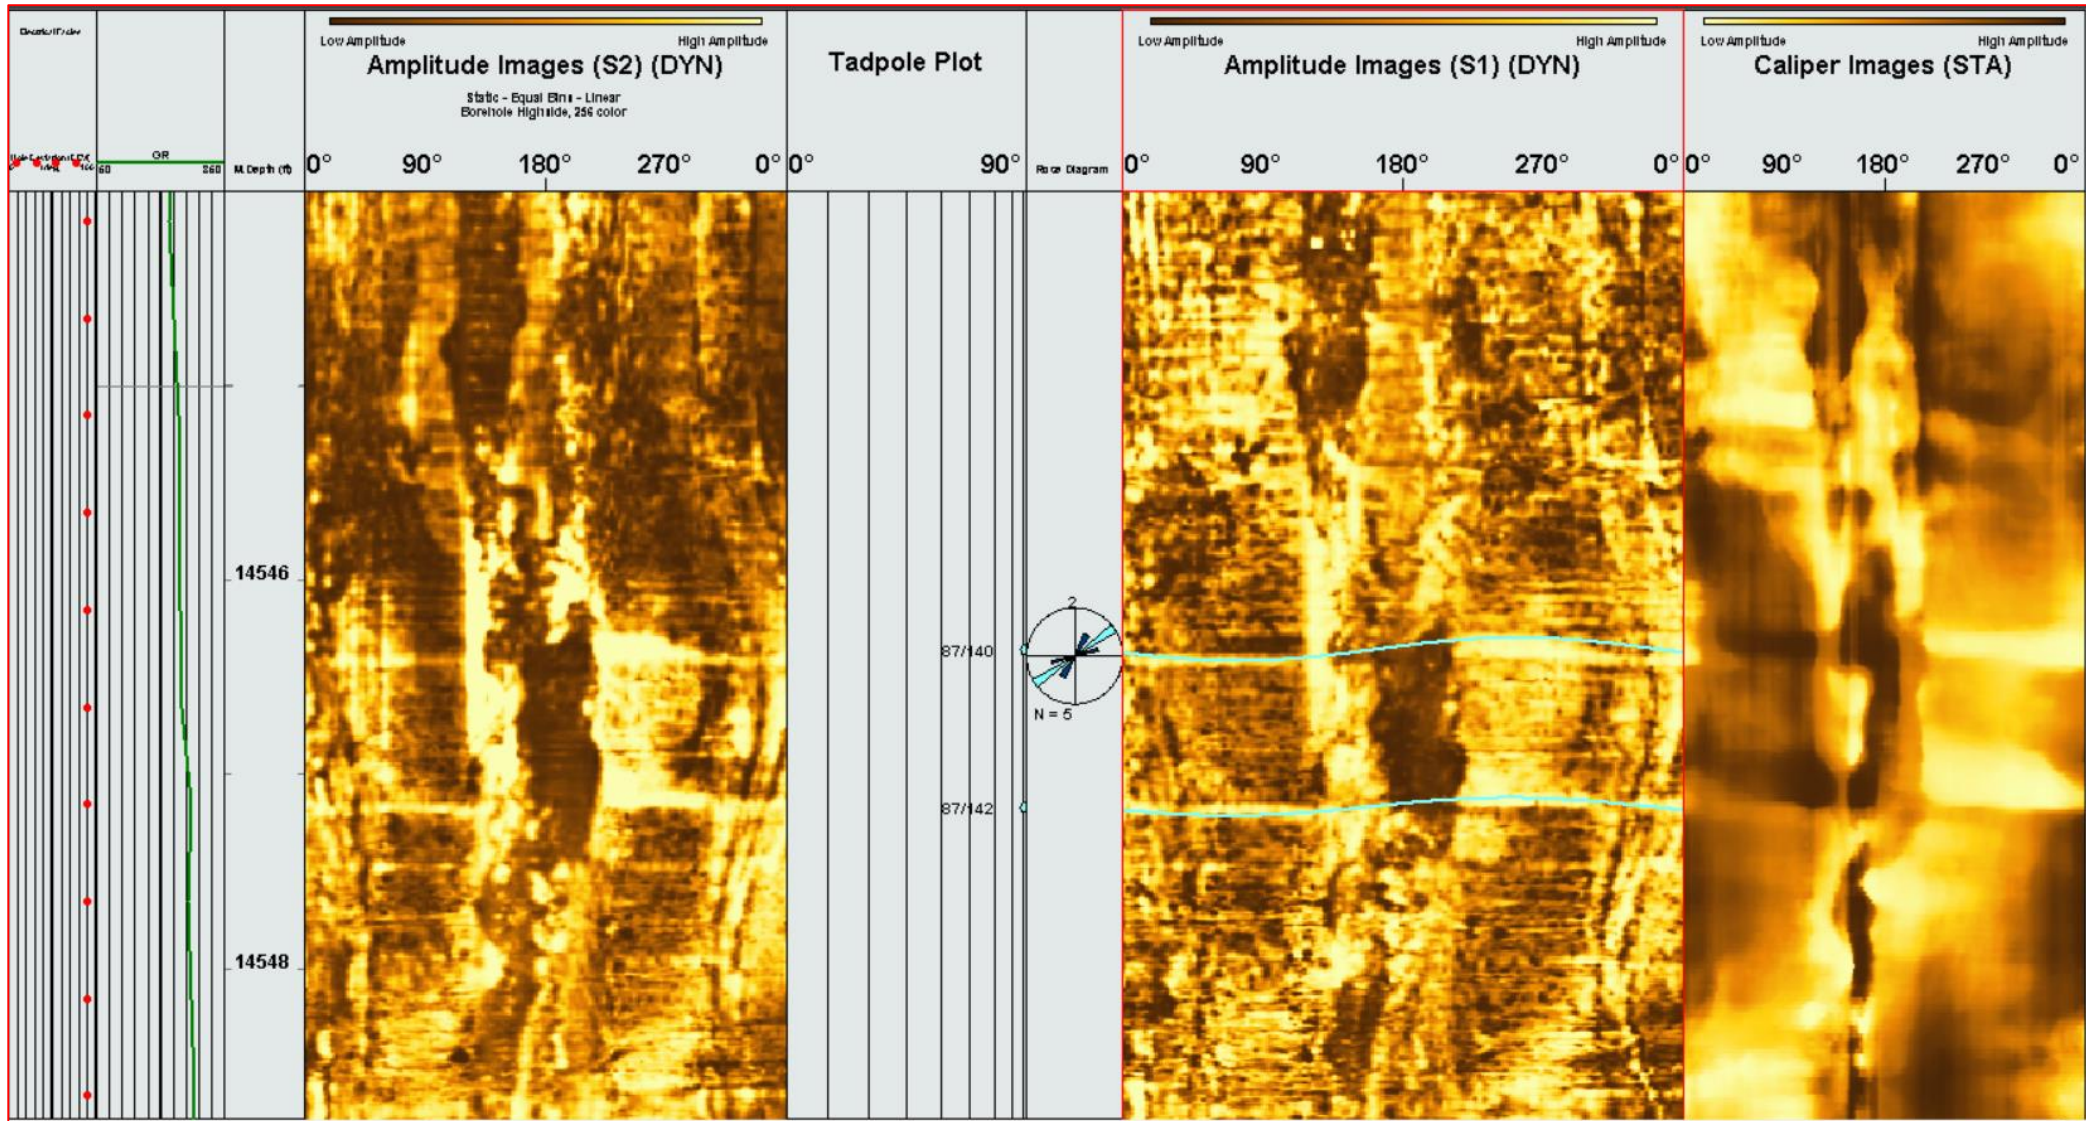
Fracture Type – High Amplitude Fracture

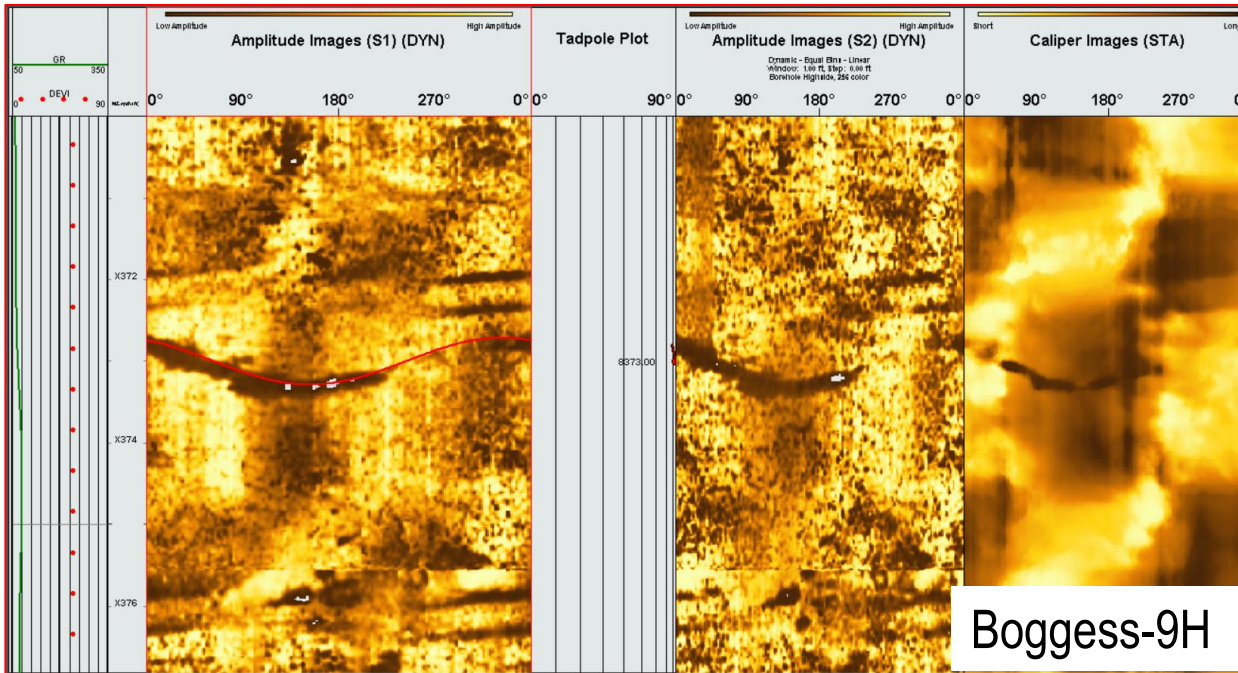
Fracture Type – Open Fracture

The open fracture is defined if a low amplitude fracture is also evident on caliper images as a “longer caliper” feature (darker)

A continuous low amplitude fracture is likely partial open indicated by caliper images

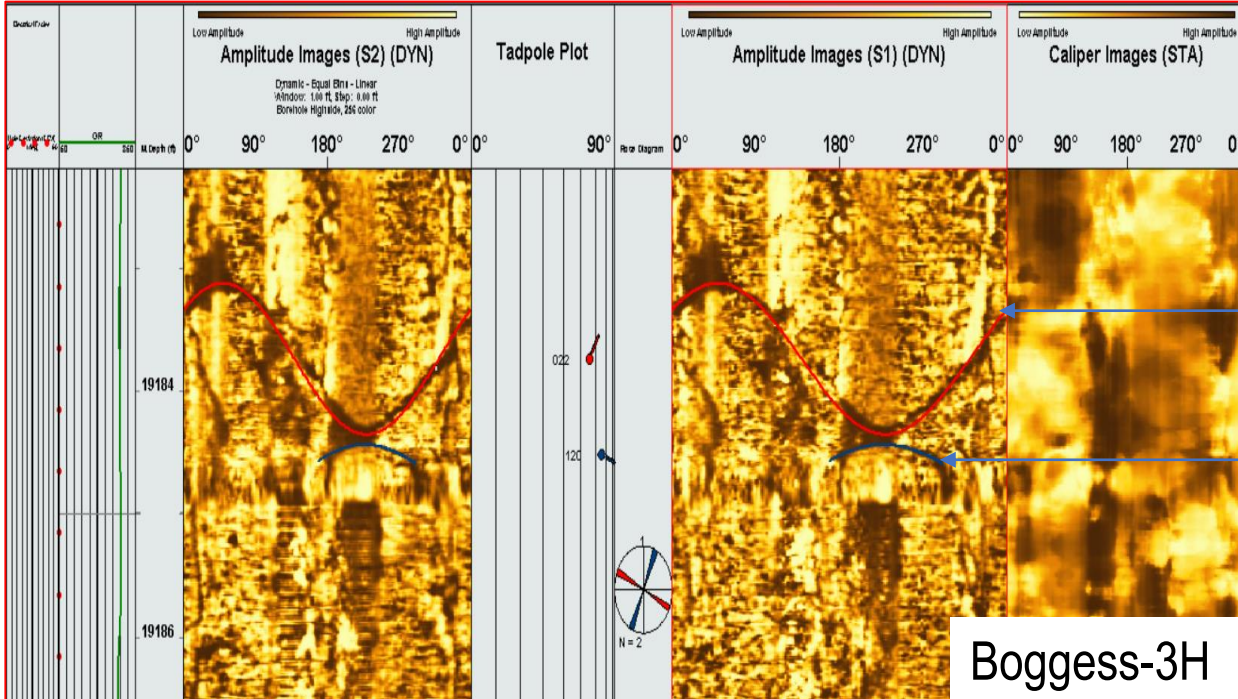
A dis-continuous low amplitude fracture which is evident on part of the wellbore only. This is the predominant fracture type in the well.

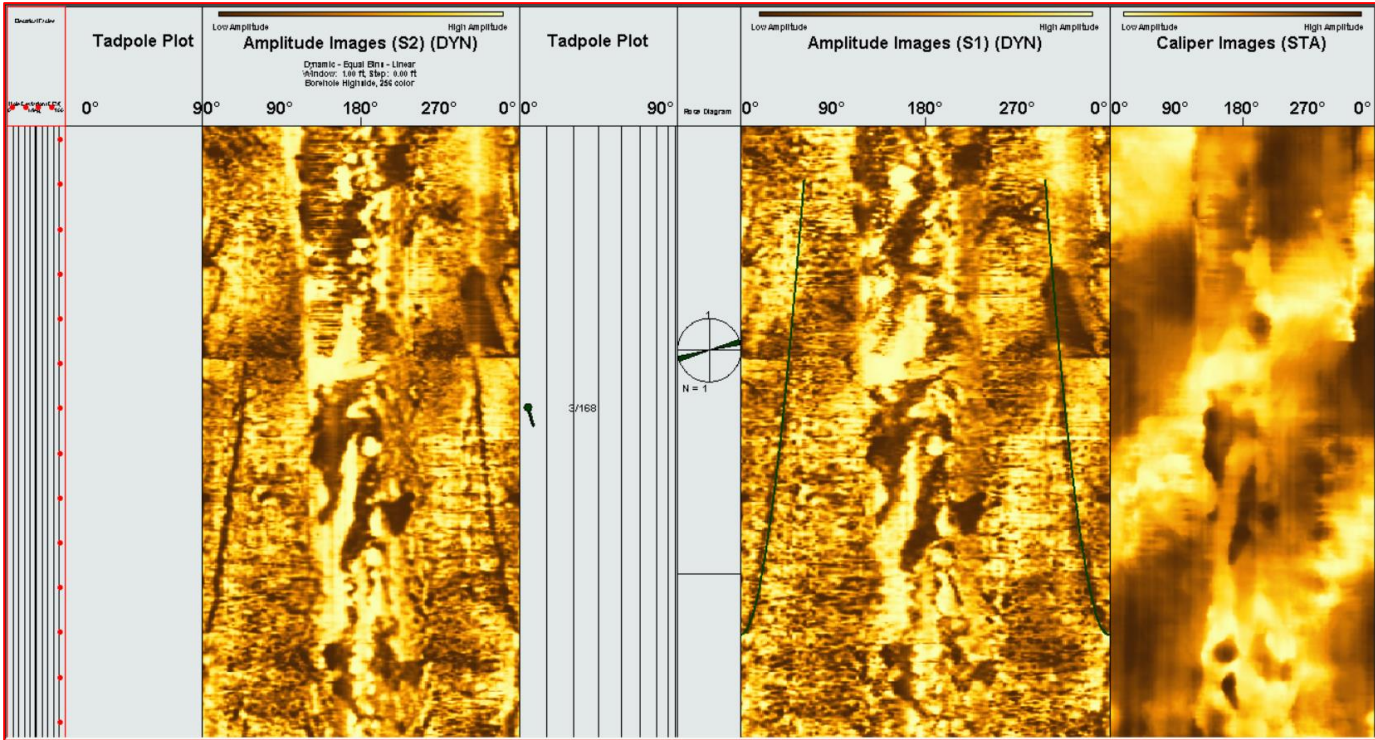
Bed boundary

Low angle Bedding

Litho-bounded
high angle
fracture

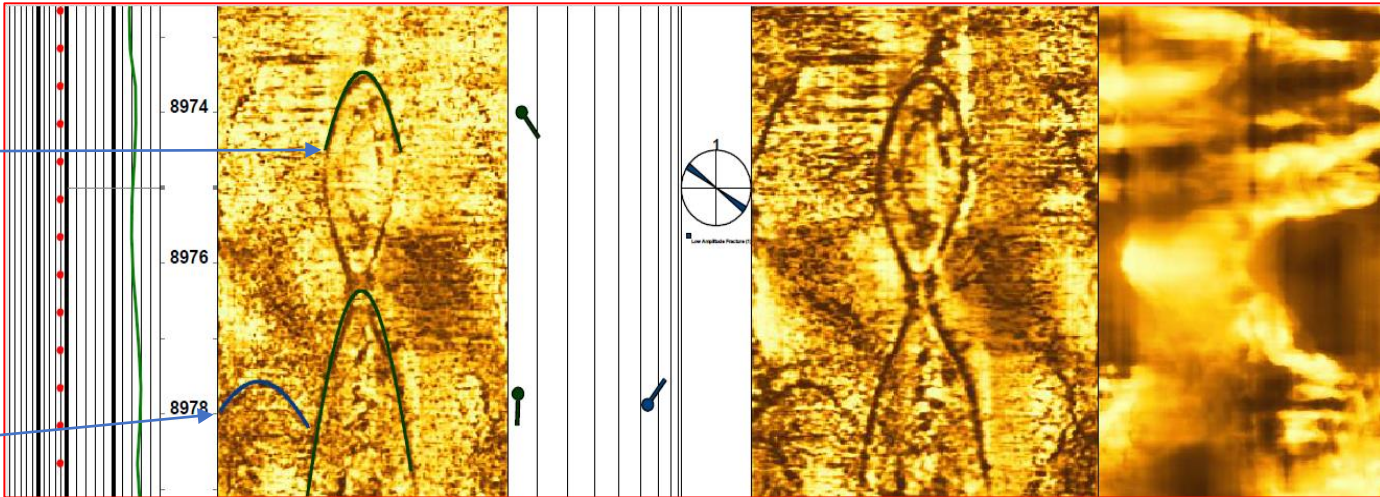
Artifact - Spiral hole

- This is observed in many sections in the wells.
